Agilent Technologies

Troubleshooting problems – Protein analysis 2100 Bioanalyzer

Troubleshooting the Protein Application

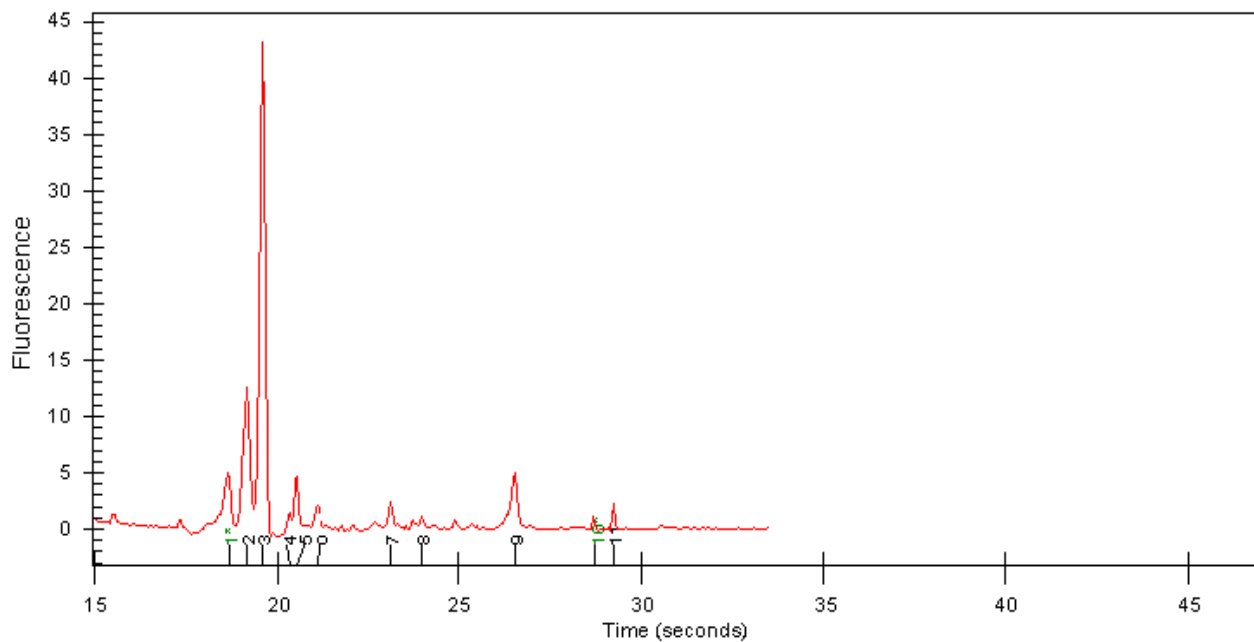
Apparently Short Run Time

Most Probable Causes	Solution
Low intensity of upper marker in the ladder. They were not assigned correctly by the software.	To correct for wrong selected upper marker in ladder, set upper marker manually. If necessary, adjust peak find settings. If peaks are detected that are not part of the ladder, exclude them. For better upper marker identification: Turn off the analysis. For correct alignment overlay electropherograms of multiple wells to clearly identify the upper marker. See Low or Missing Upper Marker in Ladder—201 for probable causes.

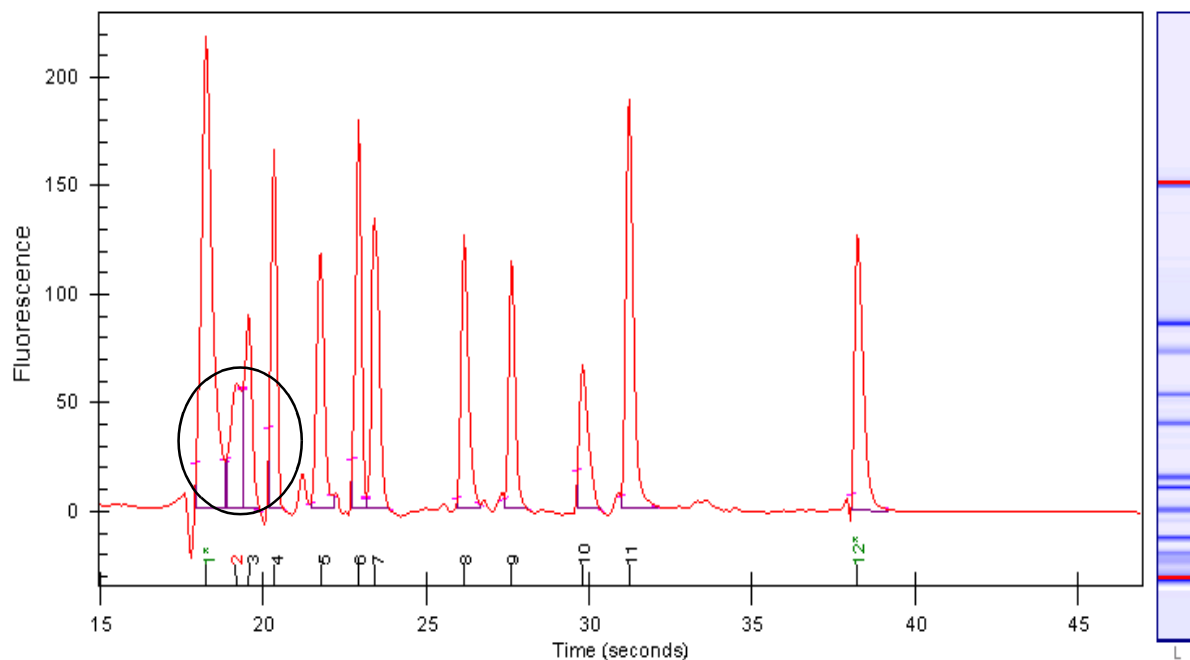
Additional Sample or Ladder Peaks

Most Probable Causes	Solution
Sample or ladder not denaturated properly.	Use fresh sample aliquot. Heat sample/denaturing solution and ladder for 5 min at 100°C
Sample/denaturing solution and/or ladder are dried out during denaturation.	Sample/denaturing solution and/or ladder were denaturated in 1.5 mL tubes. Use 0.5 mL tubes for denaturing
Chip contaminated.	Wear powder-free gloves only.
Dust particles in separation channels.	Don't touch the wells of the chip. Clean the electrodes. See Maintenance—246 for additional information. Load the chip immediately after taking it out of its sealed bag.

Probable Causes	Solution
Ladder degraded.	Refer to the Protein Reagent Kit Guide for proper ladder storage. Optional: Prepare ladder aliquots. Use a new aliquot.
Vibration of Agilent 2100 Bioanalyzer.	Don't touch Agilent 2100 Bioanalyzer during a run. Remove vibration devices, such as vortexers and vacuum pumps, from bench.

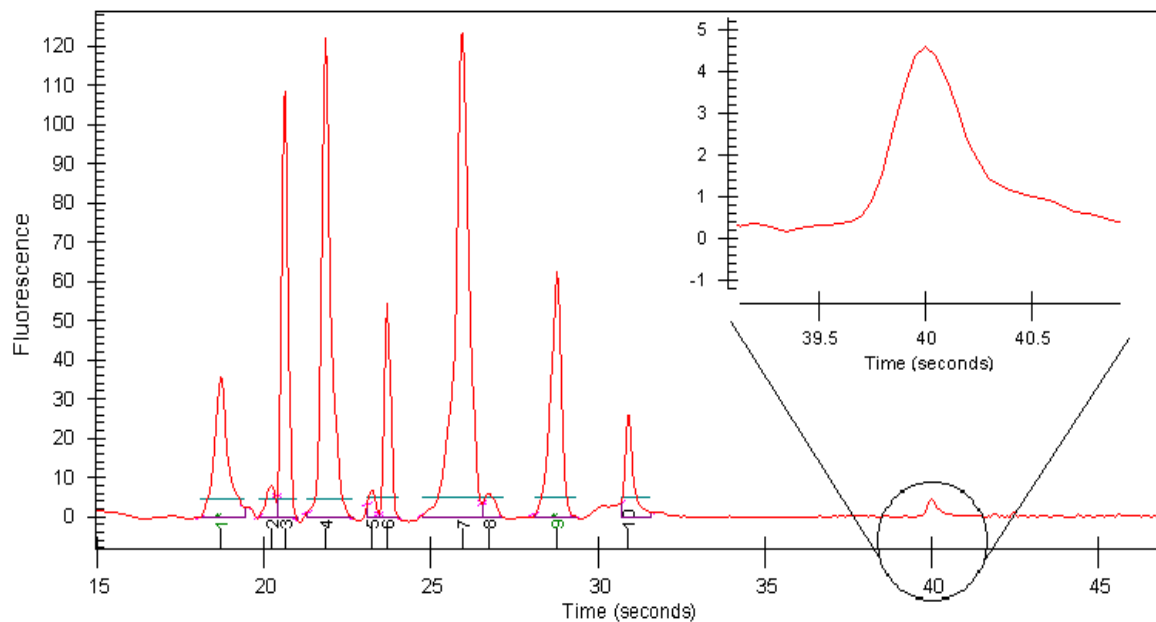
Low or Missing Upper Marker in Ladder

Most Probable Causes	Solution
Ladder degraded.	<p>For correct ladder storage and denaturation, refer to the Protein Reagent Kit Guide.</p> <p>To correct for wrong selected upper marker, set upper marker manually. If necessary, adjust peak find settings. If peaks are detected that are not part of the ladder, exclude them.</p> <p>For better upper marker identification:</p> <p>Turn off the analysis. For correct alignment overlay electropherograms of multiple wells to clearly identify the upper marker.</p>
Diluted ladder is too old.	Use diluted ladder within one day.
Probable Causes	Solution
Ladder not denaturated properly.	Use fresh ladder aliquot. Heat ladder for 5 min at 100°C
Ladder dried out during denaturation.	Ladder was denaturated in 1.5 mL tubes. Use 0.5 mL tubes for denaturating.

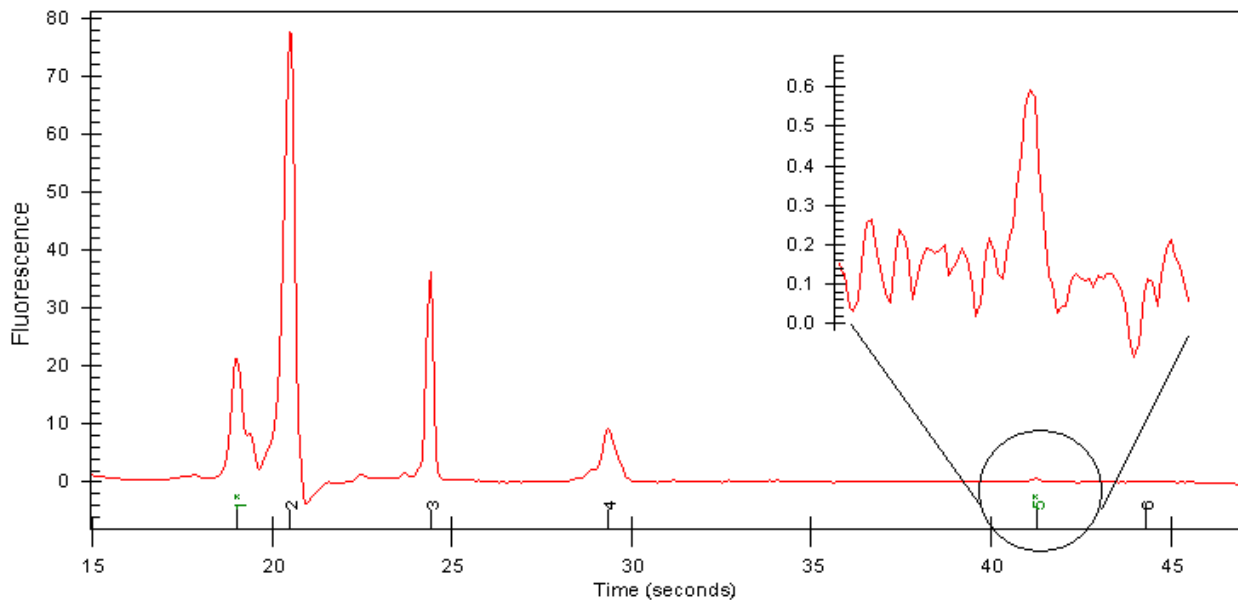
Low or Missing Upper Marker in Sample

Most Probable Causes	Solution
Sample buffer/denaturing solution not handled according to the instructions.	<p>Refer to the instructions provided with the Reagent Kit guide for storage and preparation of the sample buffer/denaturing solution.</p> <p>To correct for wrong selected upper marker, set upper marker manually. If necessary, adjust peak find settings.</p> <p>For better upper marker identification:</p> <p>Turn off the analysis. For correct alignment overlay electropherograms of multiple wells to clearly identify the upper marker.</p>
Incompatible sample component. Some components of the buffer, e.g. CHAPS, TFA, etc. interfere with the upper marker and decrease sensitivity.	<p>See Protein Reagent Kit Guide for a list of compatible buffers and buffer compounds.</p> <p>For an updated list please refer to the web-site www.agilent.com/chem/labonachip.</p> <p>If necessary dilute, dialyze or desalt the sample.</p> <p>It is recommended to dilute the samples 1:2, 1:4, ... with water to find the optimal dilution.</p>

Probable Causes	Solution
Samples not denaturated properly.	Use fresh sample aliquot. Heat samples with denaturing solution for 5 min at 100°C
Samples dried out during denaturation.	Samples were denaturated in 1.5 mL tubes. Use 0.5 mL tubes for denaturing.
Least Probable Causes	Solution
Upper marker was digested by proteases (cell lysates).	Add protease inhibitor cocktails to cell lysate samples.

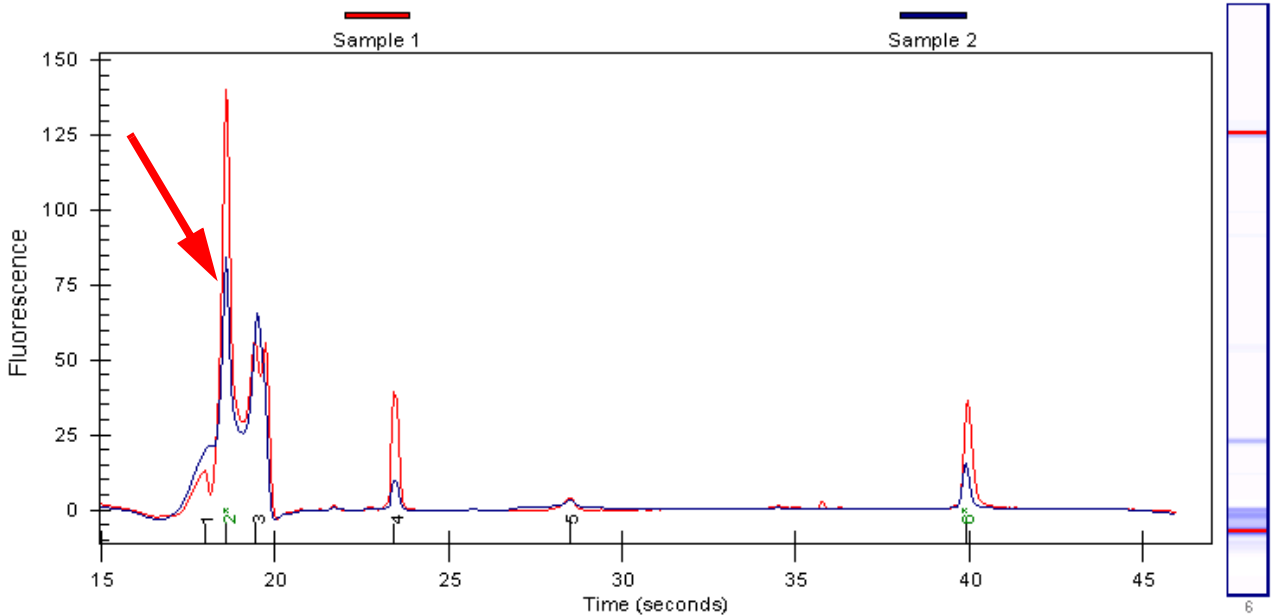
High Lower Marker Variability

Most Probable Causes	Solution
Buffer components of the sample , e.g. salts, detergents, other additives etc. interfere with the lower marker.	See Protein Reagent Kit Guide for a list of compatible buffers and buffer compounds. If necessary dilute, dialyze or desalt the sample.
Variability of ionic strength of the sample influence the lower marker intensity.

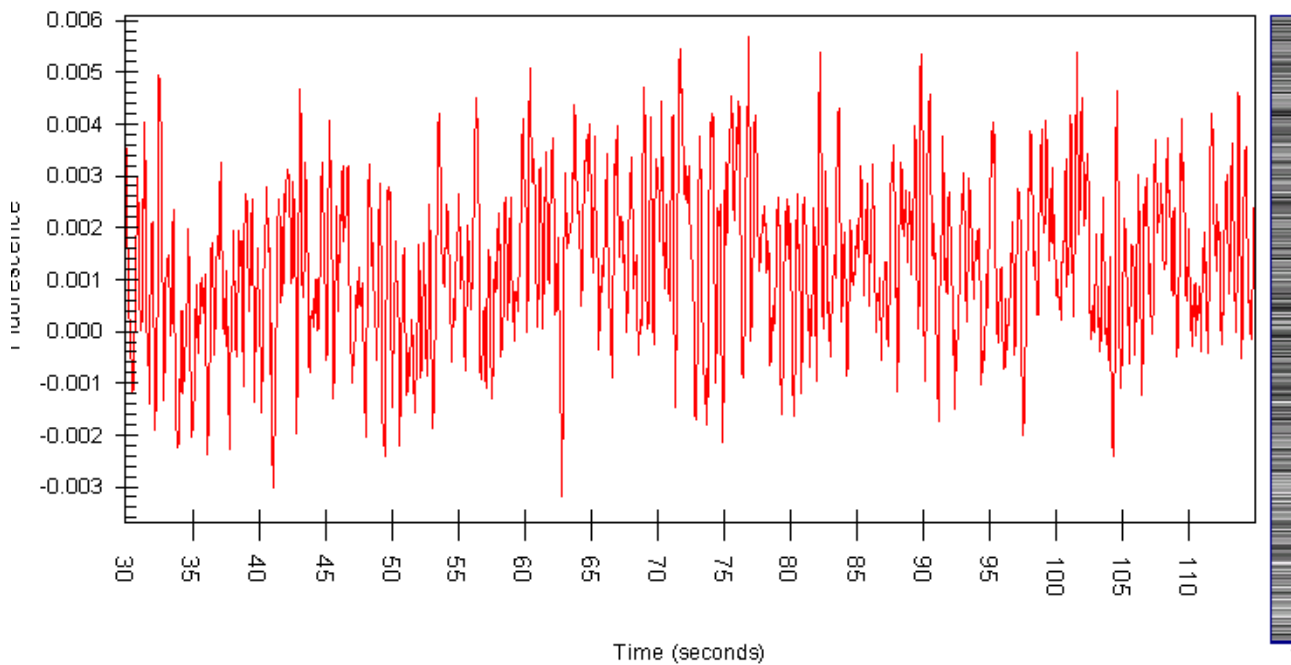
No Peaks

Most Probable Causes	Solution
Laser defective.	Check laser using the Hardware Diagnostics—48 . If the laser is defective, call Agilent Technologies.
Gel dye mix was loaded in the destain well instead of destaining solution.	Discard chip and prepare new chip according to protocol.
Probable Causes	Solution
Autofocus failure.	Check autofocus using the Hardware Diagnostics—48 . If autofocus fails, call Agilent Technologies.
Least Probable Causes	Solution
High voltage power supply defective.	Check high voltage power supply using the Hardware Diagnostics—48 . If the power supply is defective, call Agilent Technologies.
Fingerprint on focusing lens.	Clean lens like described in Lens Maintenance—270 .

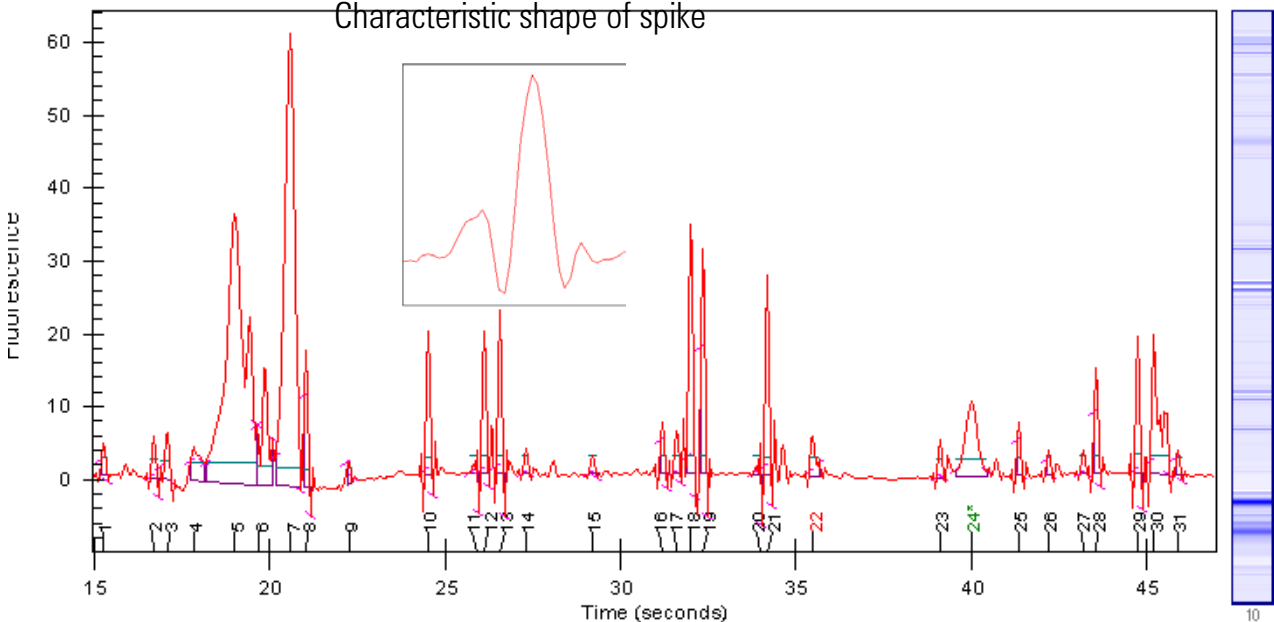
Spikes

Most Probable Causes	Solution
Chip/gel-dye mix/destaining solution contaminated.	<p>Prepare new chip with new gel-dye mix and new destaining solution:</p> <p>Wear powder-free gloves only.</p> <p>Don't touch the underside of the chip.</p> <p>Don't touch the wells of the chip.</p> <p>Clean the electrodes.</p> <p>Load the chip immediately after taking it out of its sealed bag.</p>
Gel-dye mix/destaining solution not properly prepared.	<p>Refer to the Reagent Kit Guide for proper preparation of the gel-dye mix and destaining solution. Let the dye warm up to room temperature for 20 min before preparing the gel-dye mix.</p>
Chip not properly prepared.	<p>Prepare a new chip. Allow all reagents and samples to warm up to room temperature before use.</p>

Probable Causes	Solution
Vibration of Agilent 2100 Bioanalyzer.	Don't touch Agilent 2100 Bioanalyzer during a run. Remove vibration devices, such as vortexers and vacuum pumps, from bench.
Least Probable Causes	Solution
Power outlett	Install power filter.

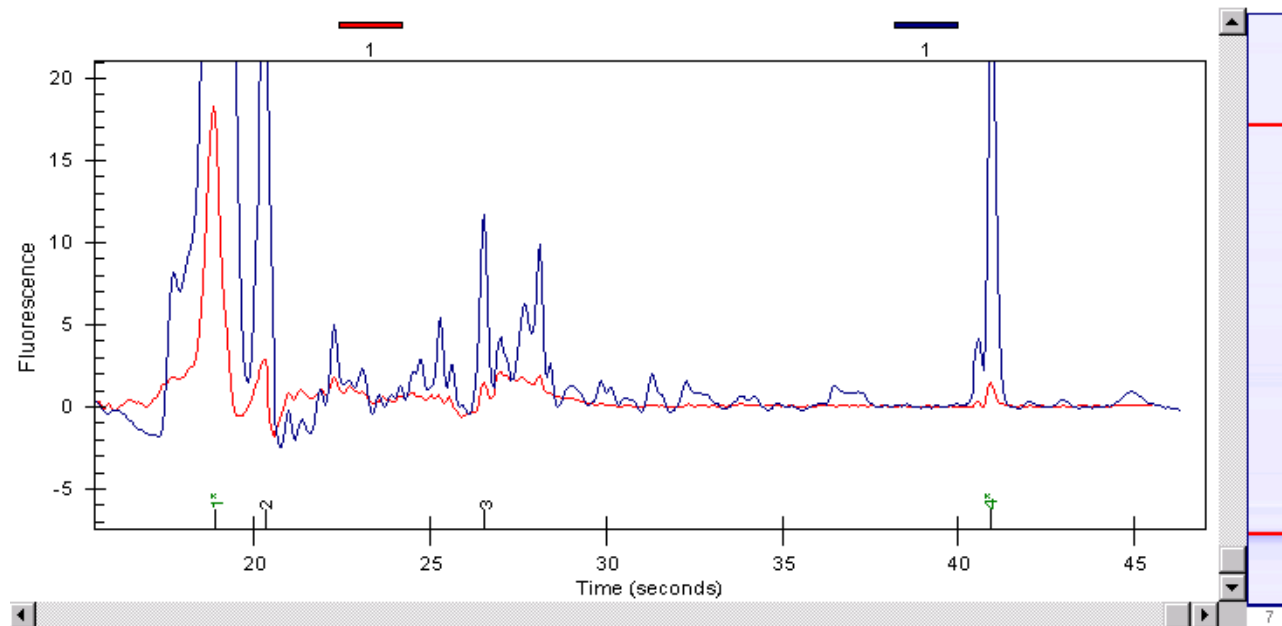
Poor Reproducibility

Most Probable Causes	Solution
Wrong peak alignment.	<p>Check if alignment is correct (wrong alignment might cause broad peaks compared to the rest of the chip).</p> <p>For better identification of the lower and upper marker:</p> <p>Turn off the analysis. For correct alignment overlay electropherograms of multiple wells to clearly identify the lower and upper marker.</p>
One Sample not denaturated properly.	Use fresh sample aliquot. Heat samples with denaturing solution for 5 min at 100°C
One Sample dried out during denaturation.	Samples were denaturated in 1.5 mL tubes. Use 0.5 mL tubes for denaturing.
Reducing agent (BME or DTT) was added in one sample and not in the other.	Refer to the Reagent Kit Guide for proper sample reduction.

Probable Causes	Solution
Diluted samples are too old.	Use diluted samples within one day.
Buffer component interferes with LDS/SDS in sample buffer.	See Protein Reagent Kit Guide for a list of compatible buffers and buffer compounds. For an updated list please refer to the web-site www.agilent.com/chem/labonachip . If necessary dilute, dialyze or desalt the sample.

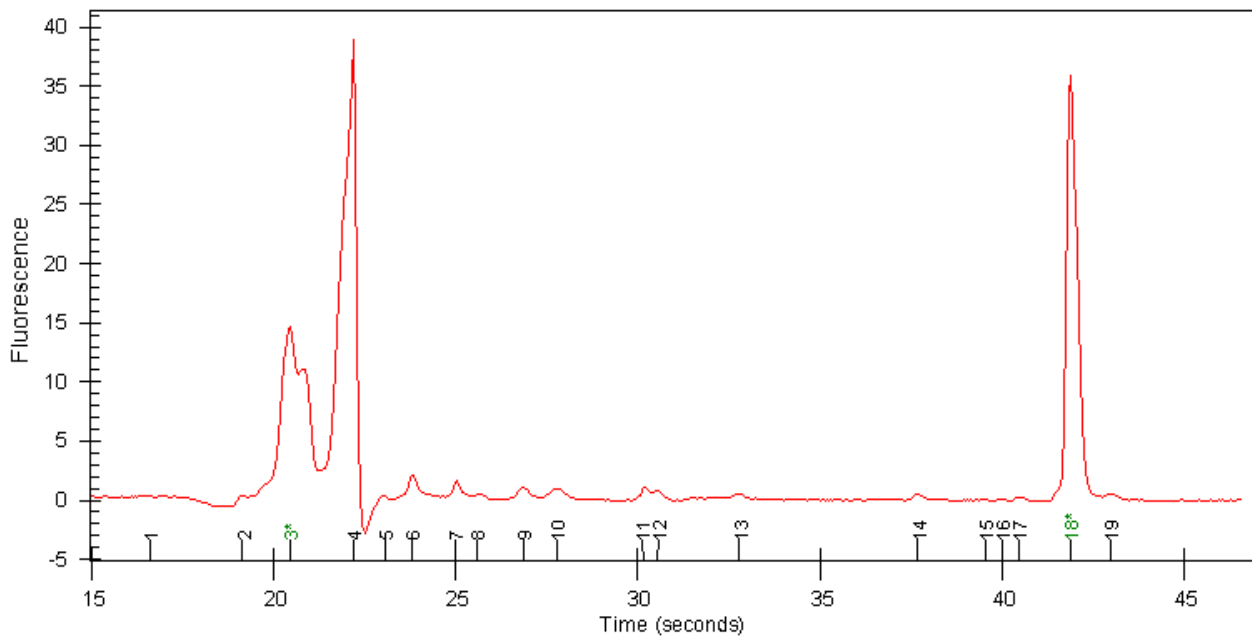
No or Low Sample Peaks

Most Probable Causes	Solution
Protein concentration in samples too low.	Use protein concentration according to specifications given in the Reagent Kit Guide.
Too high salt concentration in samples.	Sensitivity is strongly affected by salt concentration. Dilute samples in deionized H ₂ O, dialyze samples against low salt buffer or desalt samples using spin filters.
SDS not completely dissolved in dye concentrate.	Let dye concentrate equilibrate to room temperature for 20 min before use. Check for undissolved SDS crystals in the tube. Vortex dye concentrate well before use. If necessary heat the sample buffer to 37°C for 2 min.
Probable Causes	Solution
Samples not completely denatured.	Use fresh sample aliquot. Heat sample/denaturing solution for 5 min at 100°C.
Sample/denaturing solution are dried out.	Sample/denaturing solution were denatured in 1.5 mL tubes. Use 0.5 mL tubes for denaturing.
Pipetting error during preparation of mixtures.	Check dilution procedure. Check calibration of pipette.

The gel dye mix was not replaced after priming the chip. Prepare new chip according to the Protein 200 Reagent Kit Guide.

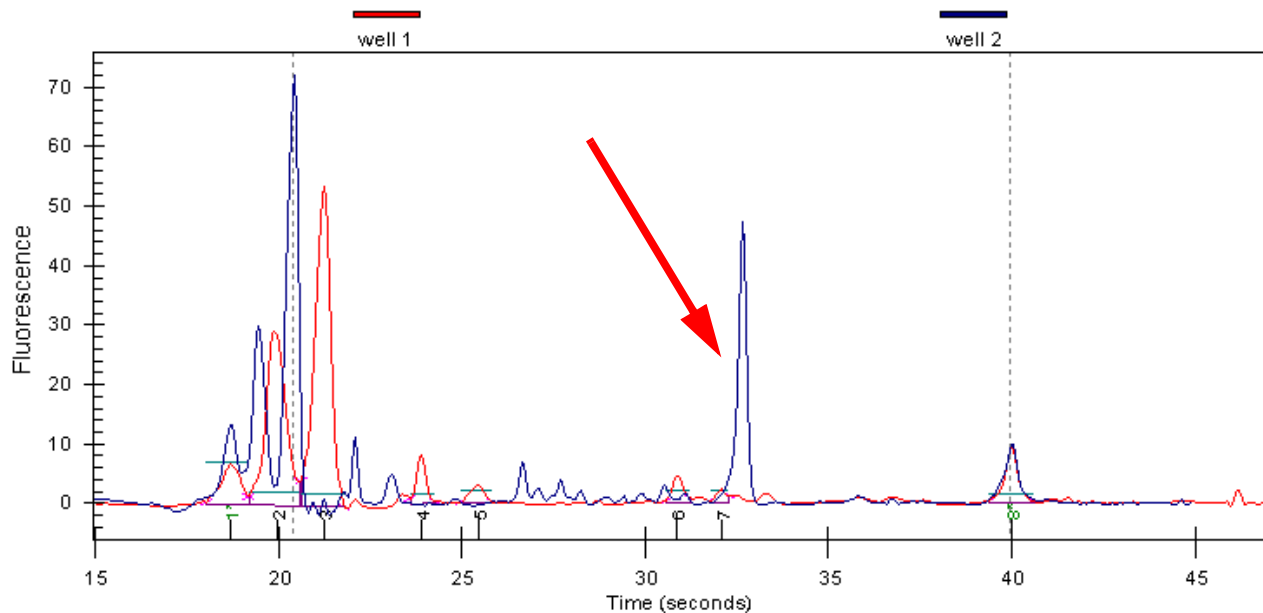
Apparently Missing Sample Peak

Most Probable Causes	Solution
Wrongly assigned upper marker.	Refer to the instructions provided with the Reagent Kit guide for storage and preparation of the sample buffer/denaturing solution.
Sample buffer/denaturing solution not handled according to the instructions.	To correct for wrong selected upper marker, set upper marker manually. If necessary, adjust peak find settings.
Because of low intensity, the software identified sample peak as upper marker.	For better upper marker identification: Turn off the analysis. For correct alignment overlay electropherograms of multiple wells to clearly identify the upper marker.

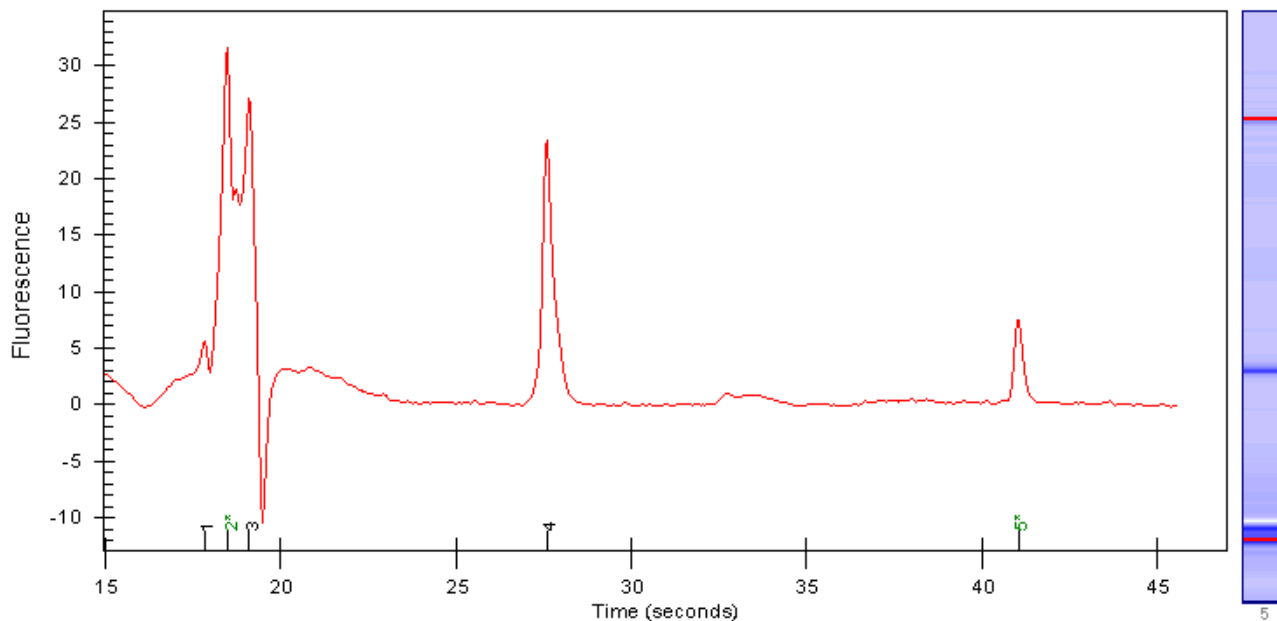
Dips

As long as the lower marker is detected, the assay performance is not affected by dips.
