Agilent 2100 Bioanalyzer Maintenance and Troubleshooting Guide

Edition November 2003

Manual Part number: G2946-90001

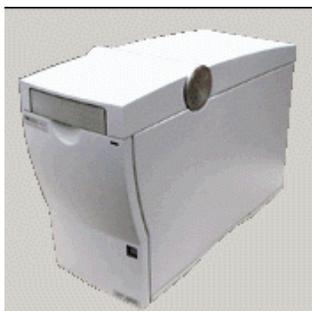
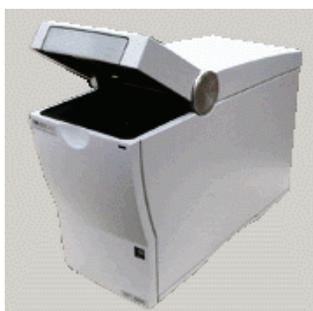
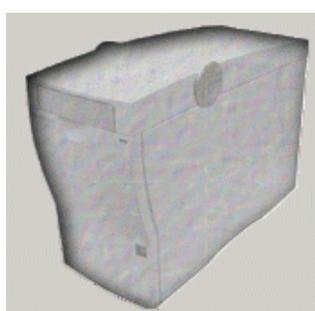
Figure 1 2100 bioanalyzer icons showing the instrument status

- 3 Open and close the lid—the icon in the instrument context should change from closed to open, see Figure 1, “2100 bioanalyzer icons showing the instrument status”

bioanalyzer online
and lid closed.

bioanalyzer online
and lid open.

Dimmed icon: instrument
switched off or not connected
to PC.

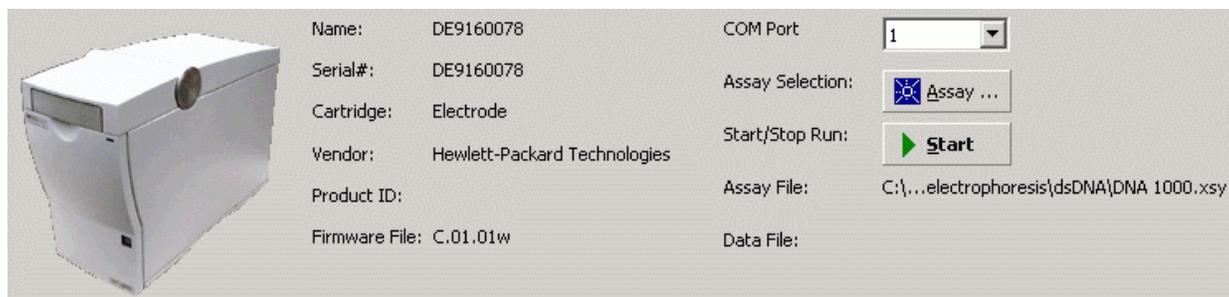
Figure 2 Bioanalyzer hardware information

If the instrument is connected successfully, additional hardware information (serial number, cartridge type,...) is displayed on top of the screen, see Figure 2, “Bioanalyzer hardware information”.

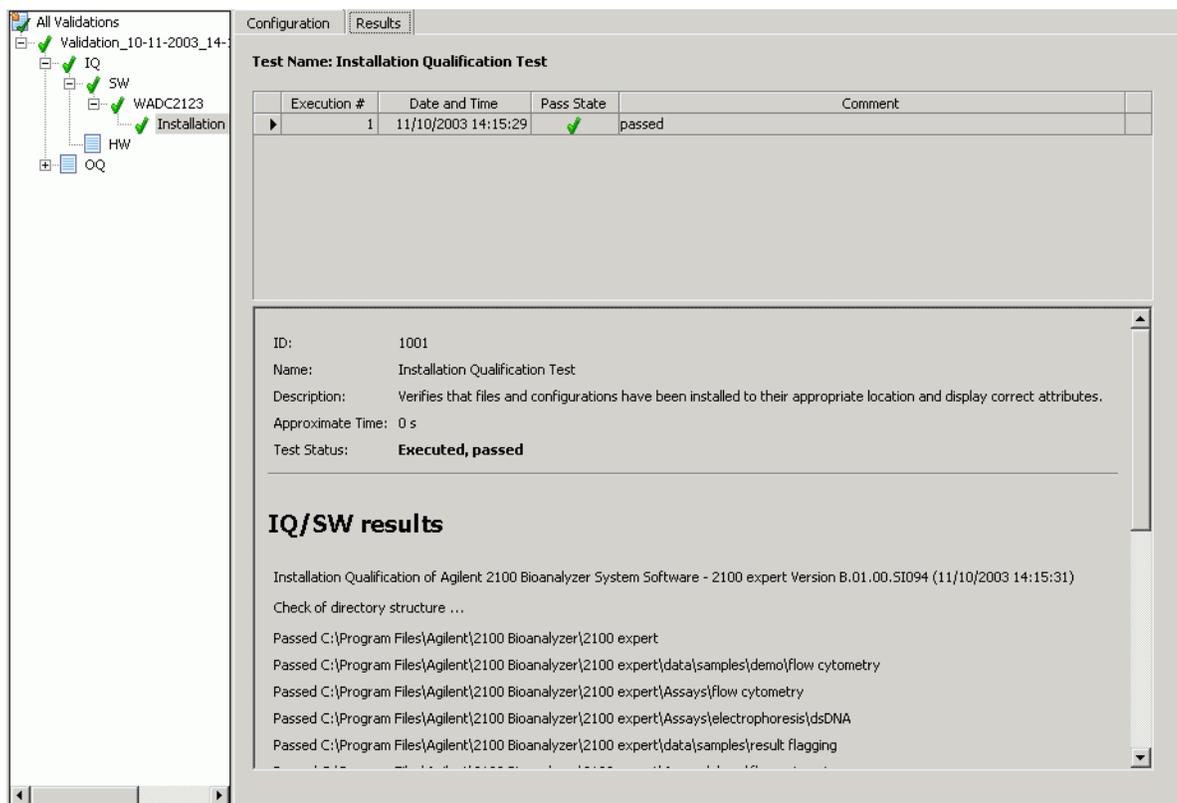
- 8 The result of the installation qualification test depends on whether the software installation is complete and no files are corrupted. To review the results, switch to the *Results* tab:

The screenshot displays the 'Results' tab of a software interface. On the left, a tree view shows a hierarchy of validation items: 'All Validations' (expanded), 'Validation_10-11-2003_14-' (expanded), 'IQ' (expanded), 'SW' (expanded), 'WADC2123' (expanded), 'Installation' (expanded), 'HW', and 'OQ'. The main area shows the 'Test Name: Installation Qualification Test'. Below this is a table with the following data:

Execution #	Date and Time	Pass State	Comment
1	11/10/2003 14:15:29	✓	passed

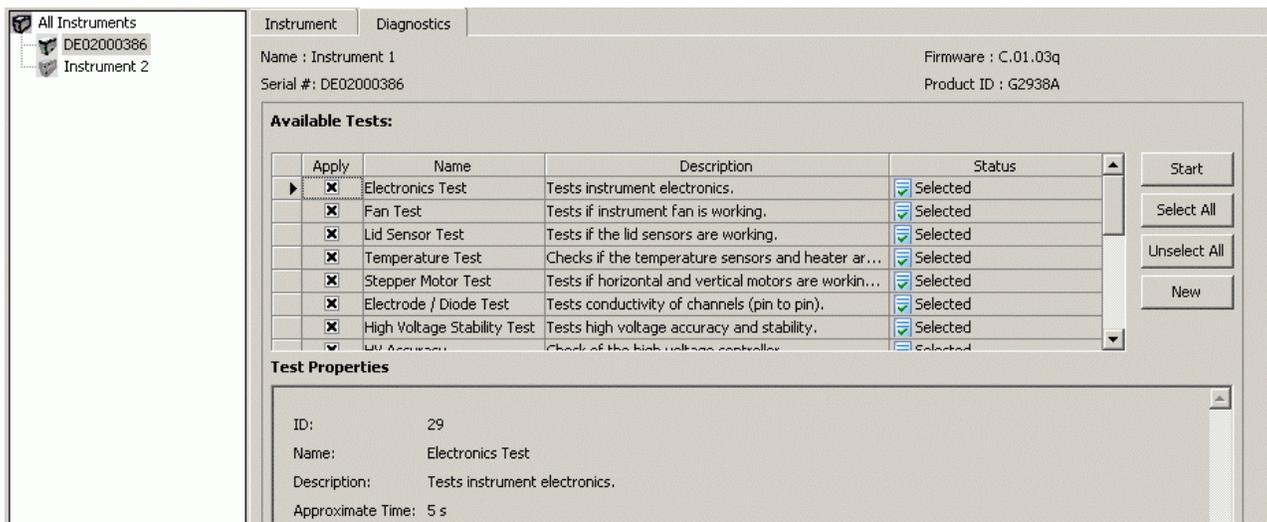
- 4 Select any of the hardware tests you want to apply from the list given or choose *Select All* to run all tests.

The screenshot shows the 'Diagnostics' tab in the software. The instrument information is as follows:

- Name: Instrument 1
- Serial #: DE02000386
- Firmware: C.01.03q
- Product ID: G2938A

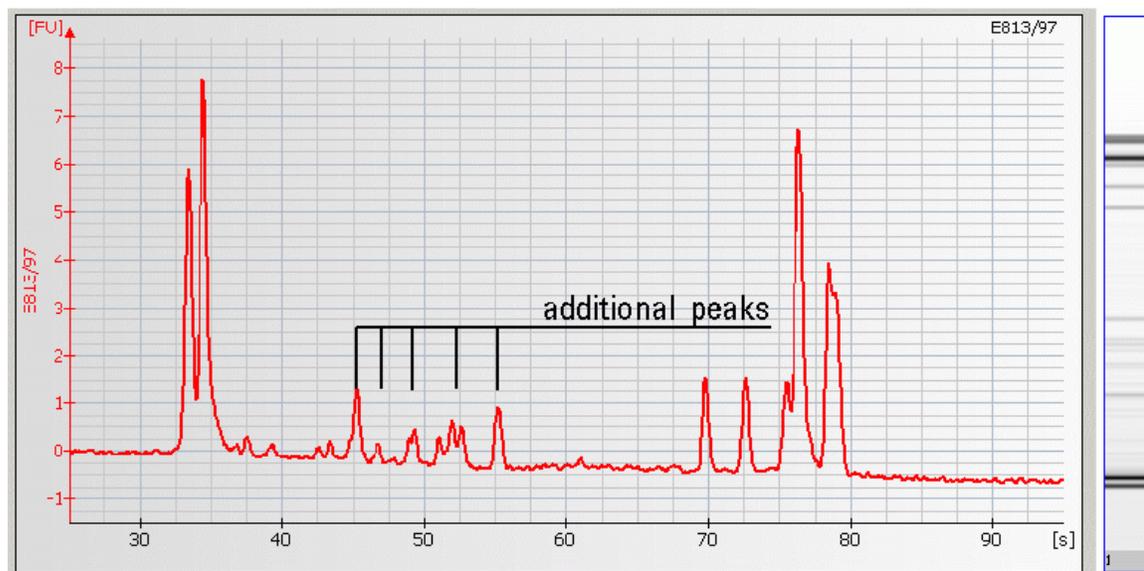
Causes for Additional Sample or Ladder Peaks

Most Probable Causes	Solution
Chip contaminated.	Wear powder-free gloves only.
Dust particles in separation channels.	Clean the electrodes. Load the chip immediately after taking it out of its sealed bag.
Probable Causes	Solution
Sample degraded or contaminated.	Always wear gloves when handling chips and samples to prevent them from getting contaminated.
Chip preparation with cold reagents.	Prepare a new chip. Allow all reagents and reagent mixes to warm up to room temperature for 30 minutes before use.
Chip not properly primed. Clogged chip priming station or wrong settings of priming station.	Use a new chip. Check chip priming station as described in " Checking the Chip Priming Station for Proper Performance - Seal Test " on page 209). Check if clip and base plate of priming station are in the correct position (see DNA Reagent Kit Guide).
Vibration of Agilent 2100 bioanalyzer.	Don't touch Agilent 2100 bioanalyzer during a run. Remove vibration devices, such as vortexers and vacuum pumps, from bench.

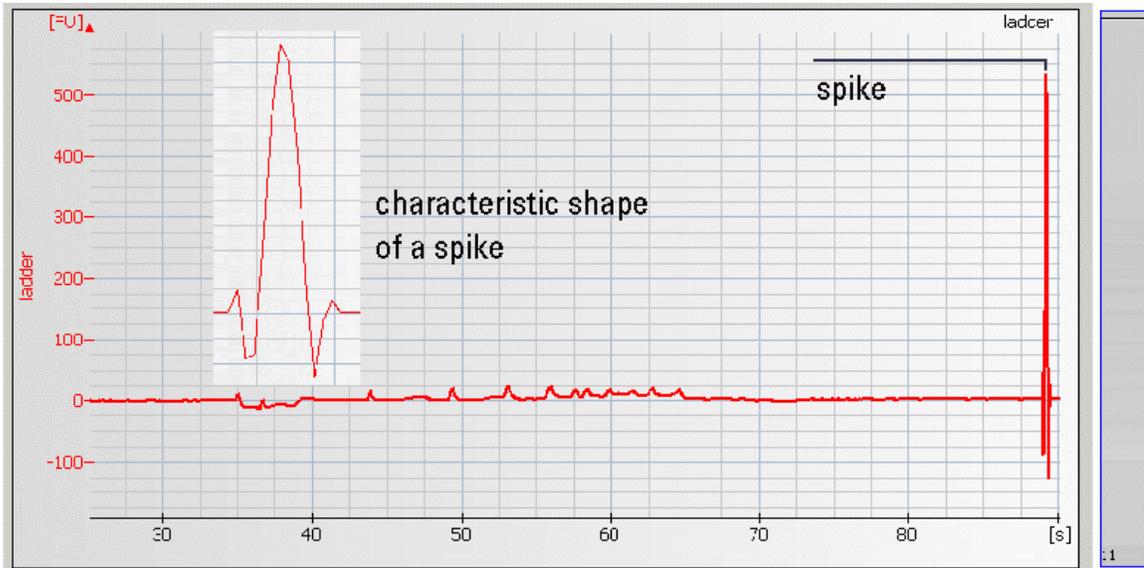
Causes for Spikes

Most Probable Causes	Solution
Vibration of Agilent 2100 bioanalyzer.	Don't touch Agilent 2100 bioanalyzer during a run. Remove vibration devices, such as vortexers and vacuum pumps, from bench.
Chip/gel-dye mix contaminated with particles.	Prepare new chip with new gel-dye mix: Wear powder-free gloves only. Don't touch the underside of the chip. Don't touch the wells of the chip. Clean the electrodes. Load the chip immediately after taking it out of its sealed bag.
Dye agglomerates present in the gel-dye mix.	Use dye concentration according to the Reagent Kit Guide. Let the dye warm up to room temperature for 30 minutes before preparing the gel-dye mix. Protect the dye from light during this time.

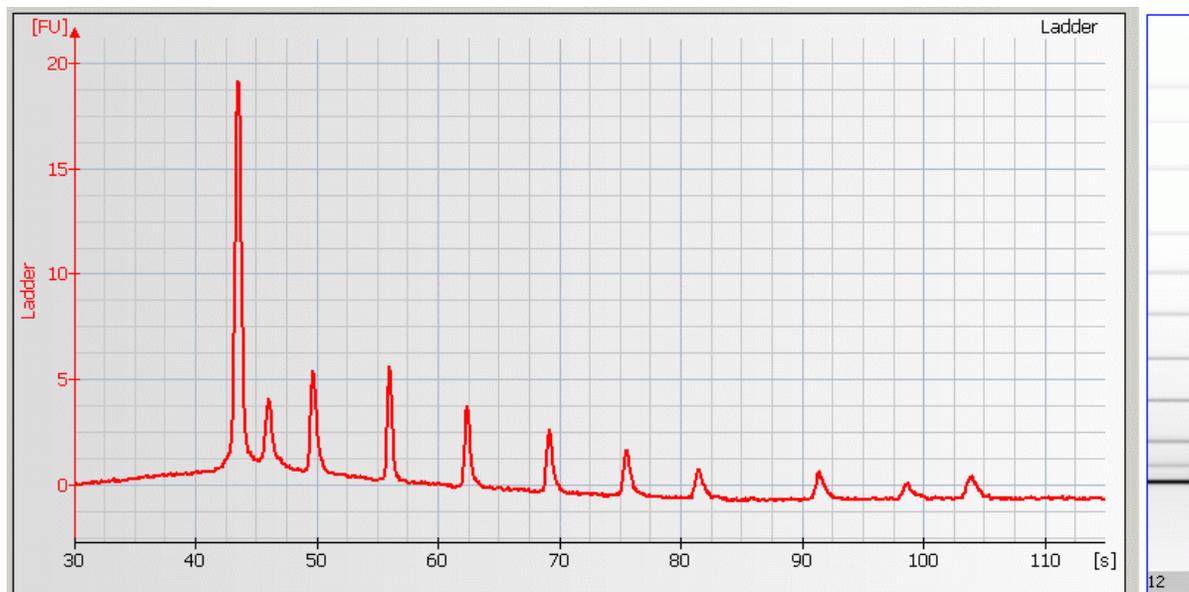
Causes for Low Sensitivity

Most Probable Causes	Solution
Dye concentration too low.	Use dye concentration according to the Reagent Kit Guide. Let the dye warm up to room temperature for 30 minutes before preparing the gel-dye mix. Protect the dye from light during this time.
Pipetting error during preparation of mixtures.	Check dilution procedure and calibration of pipette.
Chip pipetting error.	Pipette new chip. Always insert the pipette tip to the bottom of the well when dispensing the liquid. Holding the pipette at a slight angle will ensure proper dispensing of the liquid. Use appropriate pipette and tips.
Probable Causes	Solution
Fingerprint on focusing lens or on the backside of the chip.	Clean lens as described in “Cleaning the Lens” on page 222. Do not touch the underside of the chip.
Insufficient vortexing of chip.	Vortex chip for 1 minute. Only use IKA shaker for chip vortexing. Adjust speed to set-point.

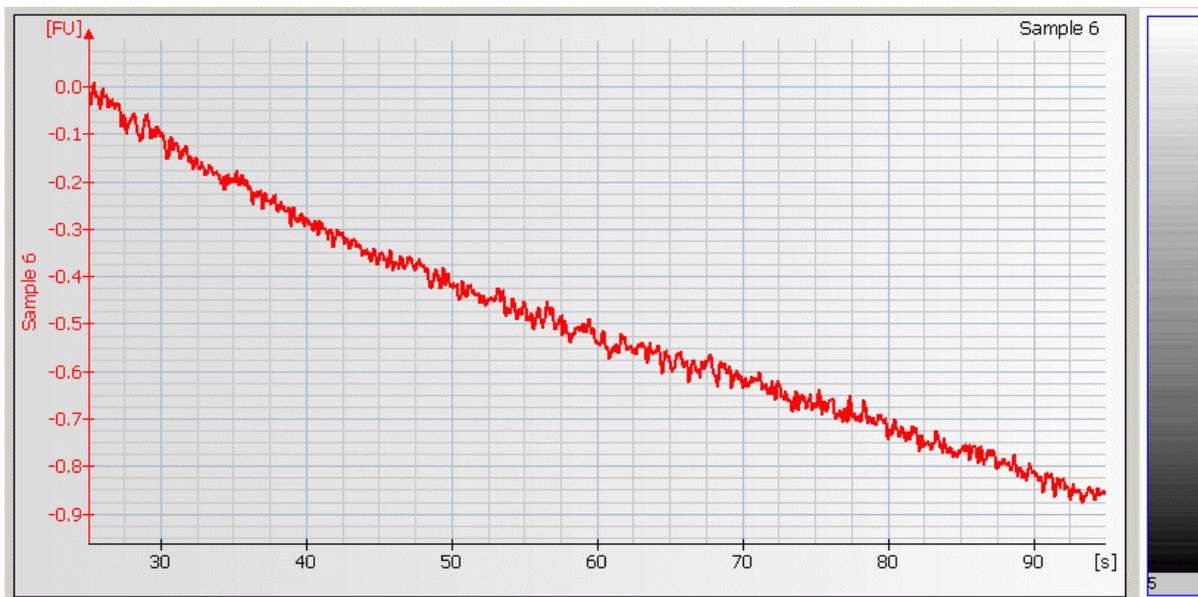
Causes for Missing Peaks

Most Probable Causes	Solution
Too high salt concentration in sample	Refer to the maximum sample buffer salt concentration as specified in the reagent kit guide. Dilute samples with deionized DNase free water if necessary.
Clogged gasket and plastic adapter of priming station	Check chip priming station as described in “Checking the Chip Priming Station for Proper Performance - Seal Test” on page 209). Clean/replace gasket and plastic adapter if necessary.
Wrong settings of the chip priming station.	Check if clip and base plate of priming station are in the right position (see Reagent Kit Guide).
Current leaks due to contaminated electrodes.	Clean electrodes with analysis-grade water and a toothbrush, see “How to clean the Pin Set of the Electrode Cartridge” on page 192.

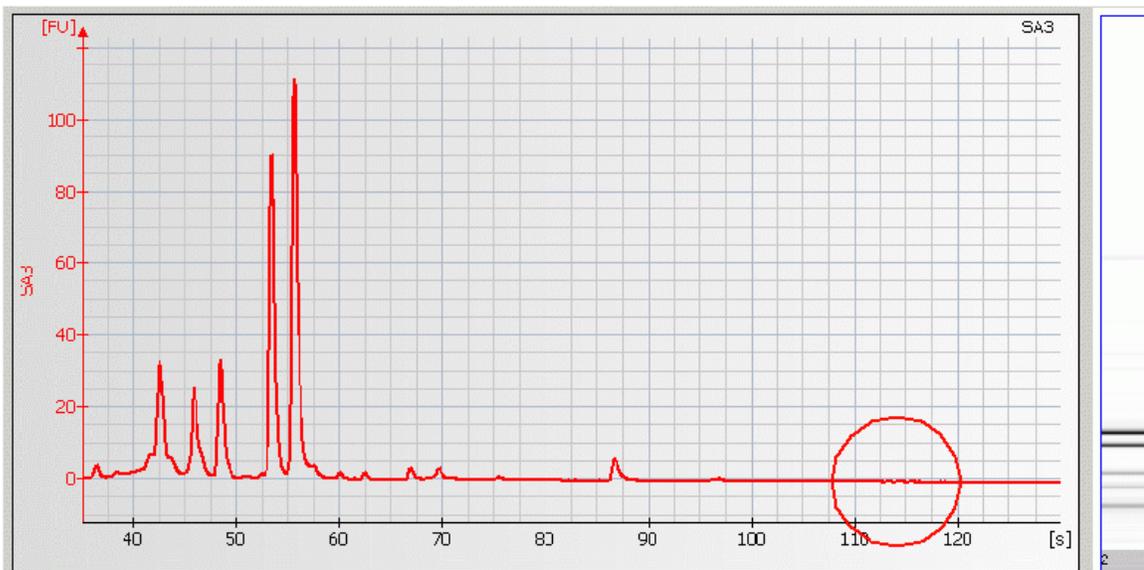
Causes for Missing Upper Marker

Most Probable Causes	Solution
Alignment of upper marker not worked properly	Manually set the upper marker: <ol style="list-style-type: none">1 In the electropherogram tab, highlight the appropriate peak in the peak table.2 With a right-mouse click, select “Manually Set Upper Marker”.
Upper marker digested by restriction enzymes.	Inactivate restriction enzyme by adding EDTA or heat inactivate according to the manufacturers instruction.
Probable Causes	Solution
Too high salt concentration in sample	Refer to the maximum sample buffer salt concentration as specified in the reagent kit guide. Dilute samples with deionized DNase free water if necessary.

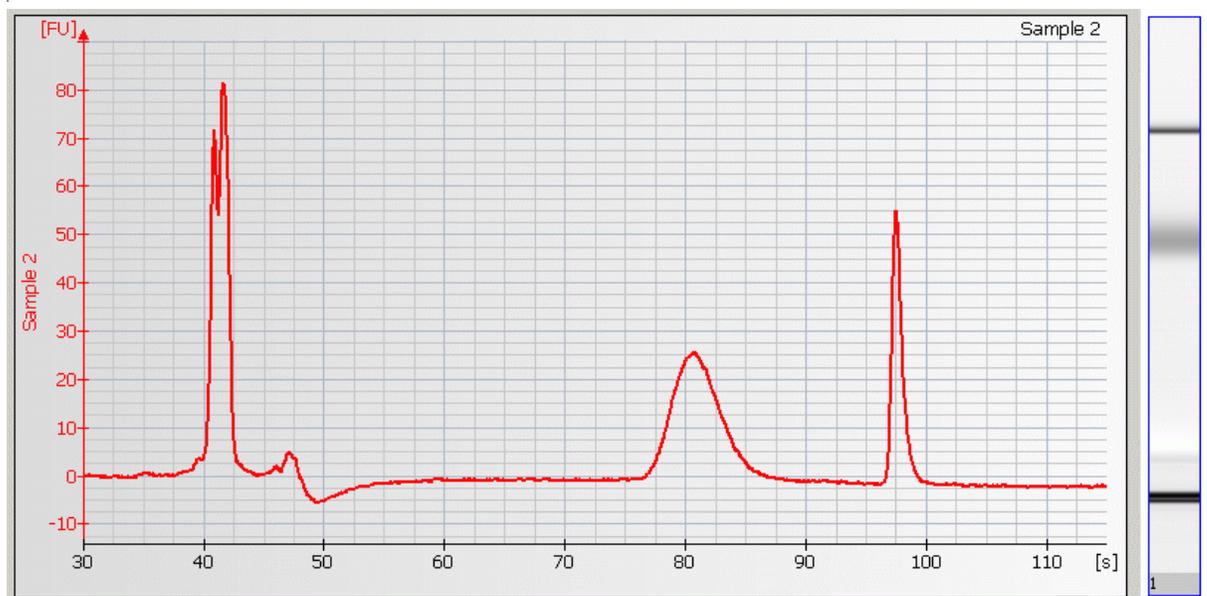
Causes for Broad Peaks

Most Probable Causes	Solution
Current leaks due to contaminated electrodes.	Clean electrodes with analysis-grade water and a toothbrush, see “How to clean the Pin Set of the Electrode Cartridge” on page 192.
Clogged gasket and plastic adapter of priming station	Check the priming station as described in “Checking the Chip Priming Station for Proper Performance - Seal Test” on page 209. Clean/replace gasket and plastic adapter if necessary.
Wrong settings of the chip priming station.	Check if clip and base plate of priming station are in the right position (see Reagent Kit Guide).
Dye concentration too high.	Use dye concentration according to the Reagent Kit Guide. Let the dye warm up to room temperature for 30 minutes before preparing the gel-dye mix.
Probable Causes	Solution
Genomic DNA or cDNA contamination.	Check DNA preparation procedure.

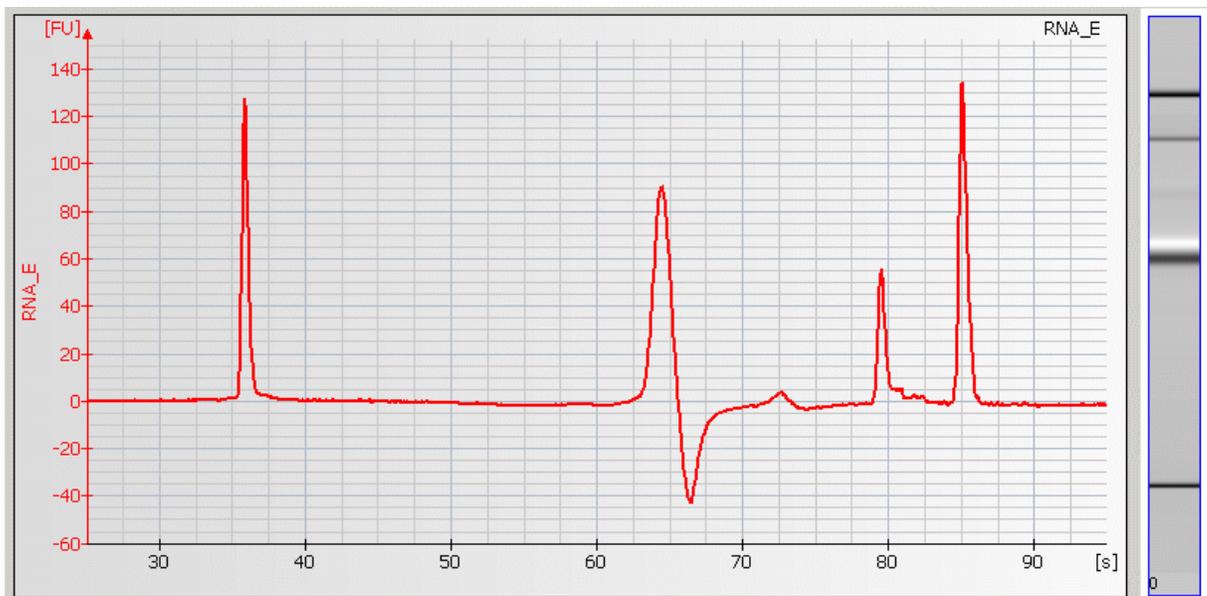
Causes for Baseline Dips

Probable Causes	Solution
Too high sample concentration.	Use sample concentration according to the DNA Reagent Kit Guide.
Sample impurities: e.g. genomic DNA, ss DNA, etc.	Check DNA-isolation protocol. If possible, clean up samples.
Probable Causes	Solution
Dye concentration too low.	Use dye concentration according to the Reagent Kit Guide. Let the dye warm up to room temperature for 30 minutes before preparing the gel-dye mix. Protect the dye from light during this time.
Least Probable Causes	Solution
Autofocus failure.	Check autofocus by means of the “Hardware Diagnostics” on page 33. If autofocus fails, contact Agilent Technologies.

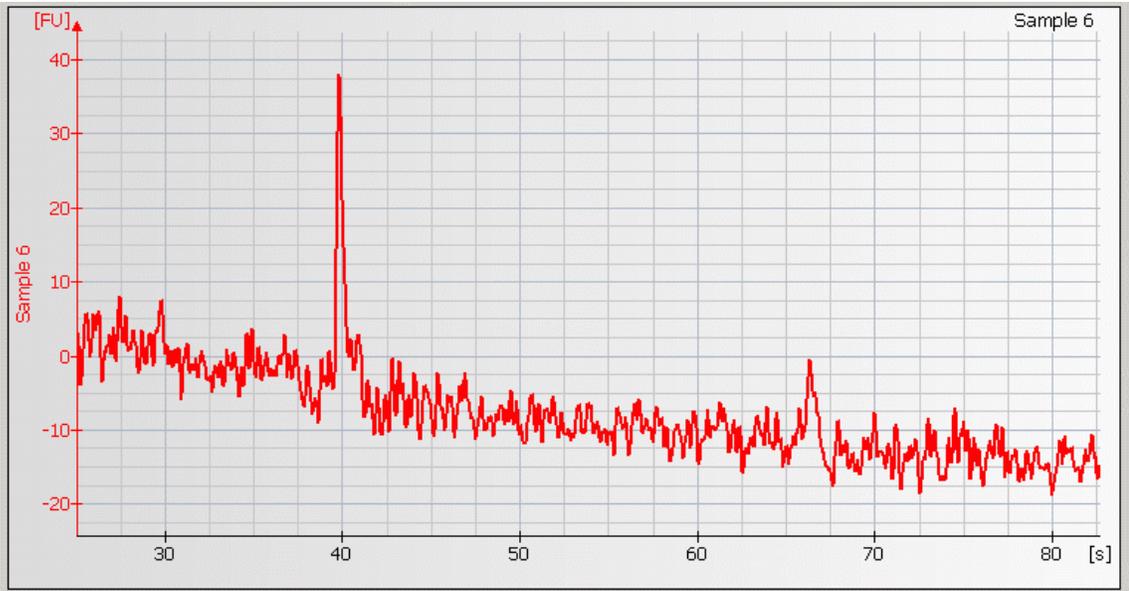
Causes for Baseline Noise

Most Probable Causes	Solution
Fingerprint on focusing lens or on the backside of the chip.	Clean lens as described in “ Cleaning the Lens ” on page 222. Do not touch the underside of the chip.
Probable Causes	Solution
Autofocus failure or High voltage power supply defective	Check autofocus and high voltage power supply by means of the “ Hardware Diagnostics ” on page 33. If tests fail, contact Agilent Technologies.
Least Probable Causes	Solution
Chip contaminated.	Wear powder-free gloves only. Don't touch the underside of the chip. Don't touch the wells of the chip. Clean the electrodes. Load the chip immediately after taking it out of its sealed bag.

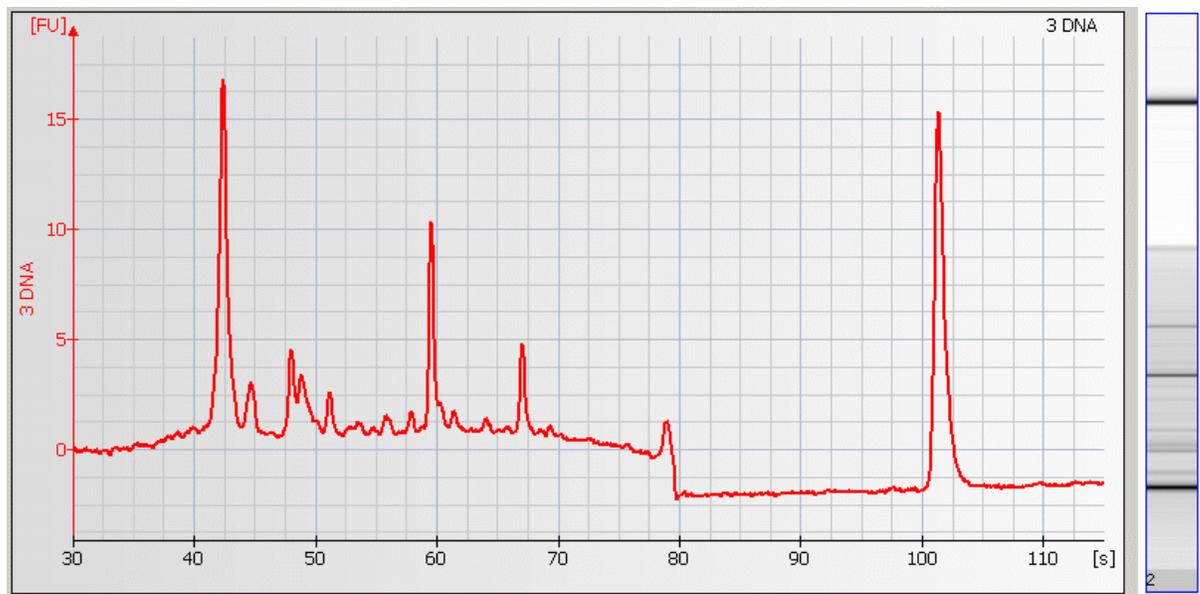
Causes for Baseline Jumps

Most Probable Causes	Solution
Vibration of Agilent 2100 bioanalyzer.	Remove vibration devices, such as vortexers and vacuum pumps, from bench.
Instrument lid was touched during the run.	Don't touch Agilent 2100 bioanalyzer during a run.
Least Probable Causes	Solution
Laser defective.	Check Laser by using the “ Hardware Diagnostics ” on page 33.If the laser test fails, contact Agilent Technologies.

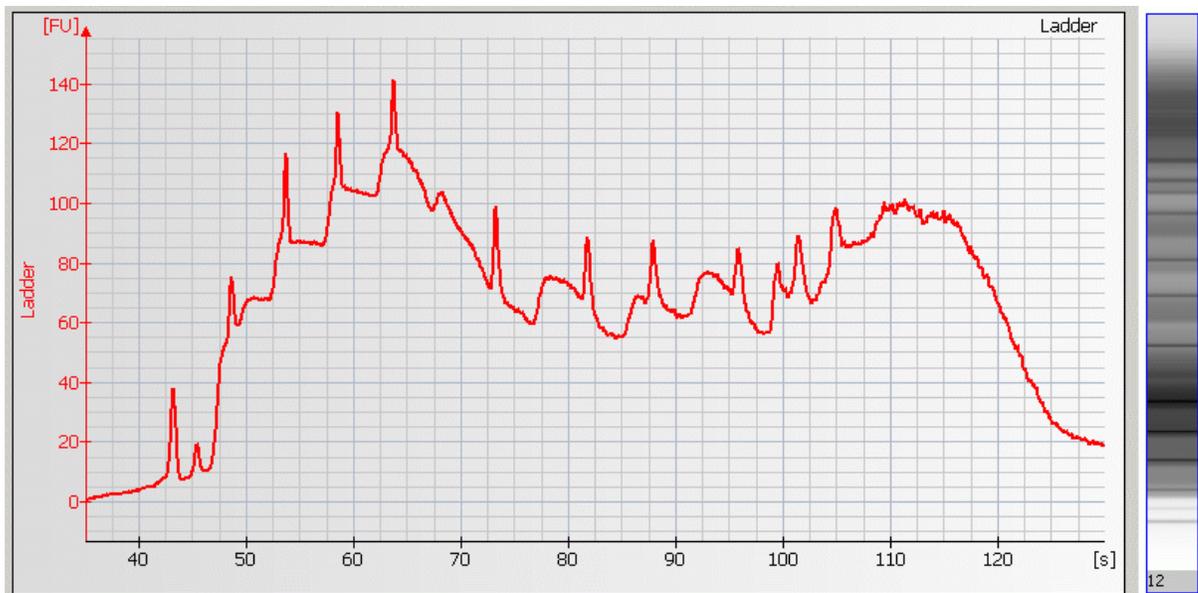
Causes for Wavy Baseline

Most Probable Causes	Solution
Leak current due to dirty electrodes.	Clean electrodes as described in “How to clean the Pin Set of the Electrode Cartridge” on page 192.
Detergents in PCR-buffer lowers surface tension in wells of chip. This leads to liquid spill on top of the chip during vortexing. As a result leak currents during the run will occur.	Prepare a new chip. Lower vortexing speed or mix samples manually.
Dye concentration too low.	Use dye concentration according to the Reagent Kit Guide. Let the dye warm up to room temperature for 30 minutes before preparing the gel-dye mix.

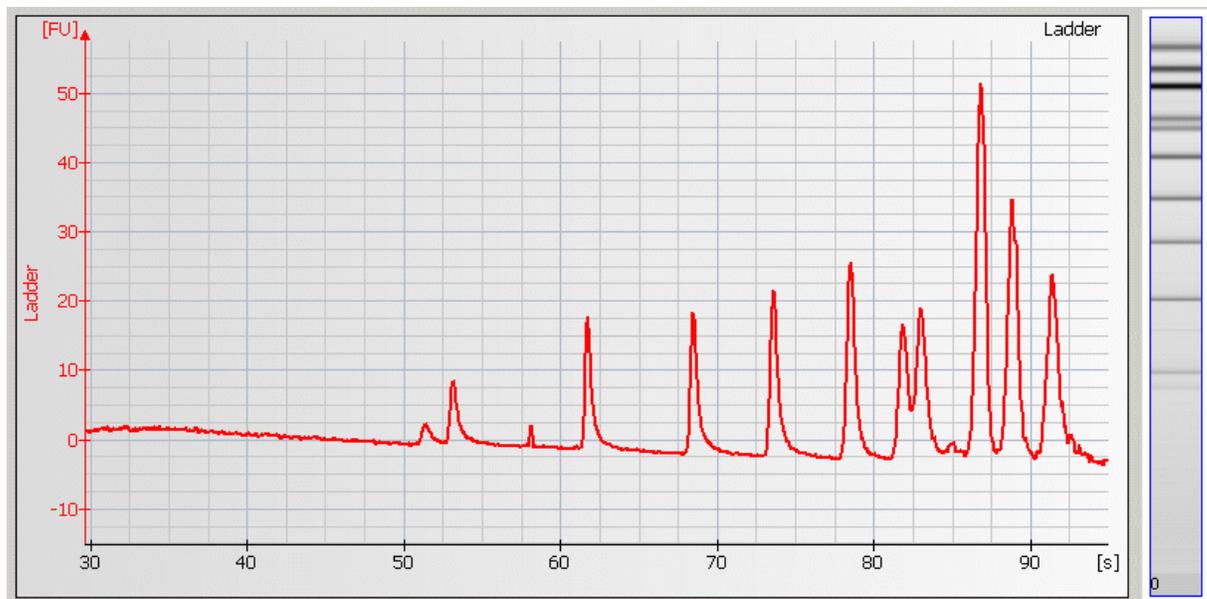
Causes for Late Migration

Most Probable Causes	Solution
Vortex speed too high.	Vortex at lower (medium) speed. For chips use only the IKA vortexer.
Leak current due to dirty electrodes.	Clean electrodes as described in “How to clean the Pin Set of the Electrode Cartridge” on page 192.
Detergents in PCR-buffer lowers surface tension in wells of chip. This leads to liquid spill on top of the chip during vortexing. As a result leak currents during the run will occur.	Prepare a new chip. Lower vortexing speed or mix samples manually.
Dye concentration too low.	Use dye concentration according to the Reagent Kit Guide. Let the dye warm up to room temperature for 30 minutes before preparing the gel-dye mix.
Probable Causes	Solution
Vortex adapter not connected tightly.	Press vortex adapter tightly on mount (vortex adapter must not rock). Replace vortex adapter (p/n 5022-2190) as described in “Maintenance of the Vortexer: Changing the Adapter” on page 228.

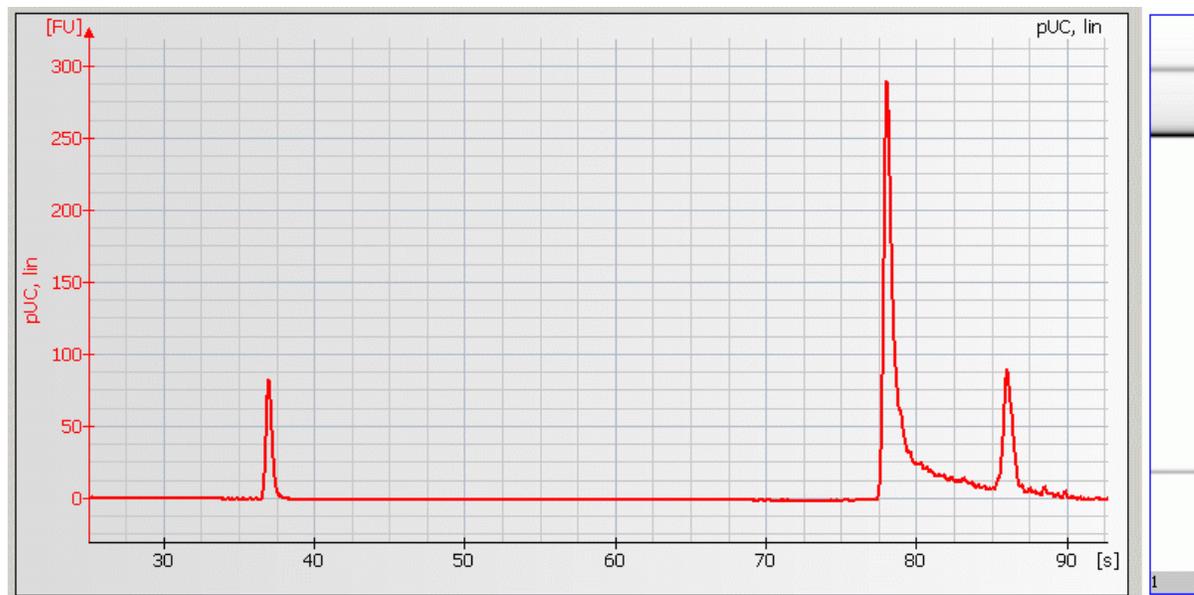
Causes for Peak Tailing

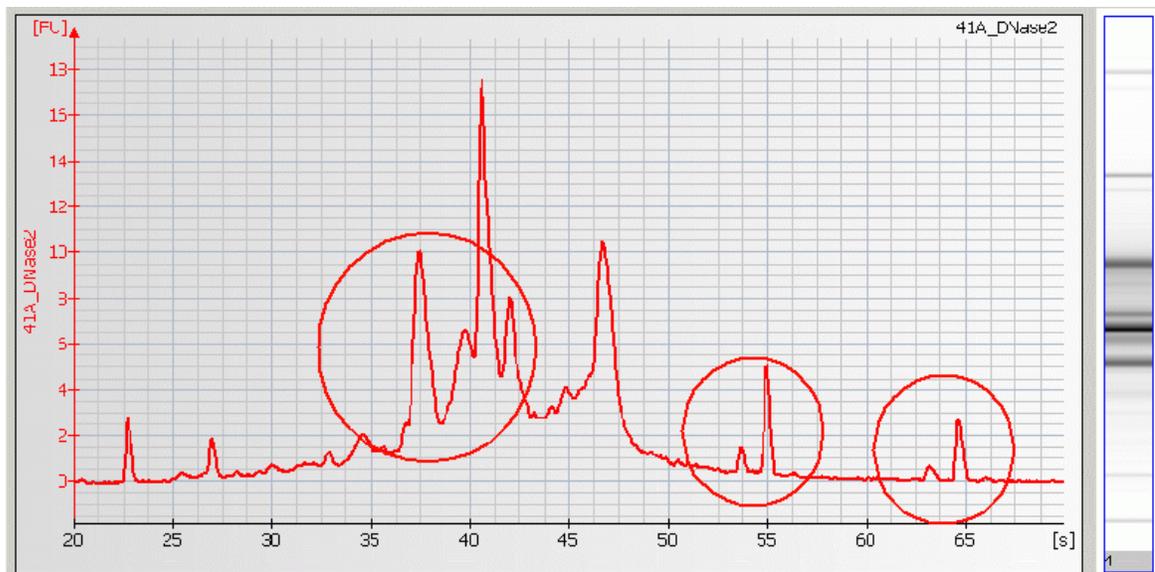
Additional Sample or Ladder Peak

Causes for Additional Sample or Ladder Peaks

Most Probable Causes	Solution
Gel-dye mix expired.	Use prepared gel-dye mix within one day.
RNA ladder/sample not denaturated properly.	Heat ladder/samples at 70 °C for 2 minutes.
Particles in tubes.	For reagent preparation, use tubes that are supplied with the kit. Do not use autoclaved tubes.
Chip contaminated.	Wear powder-free gloves only.
Dust particles in separation channels.	Don't touch the wells of the chip. Clean the electrodes. Load the chip immediately after taking it out of its sealed bag.
Probable Causes	Solution
Dye agglomerates present in the gel-dye mix.	Use dye concentration according to the Reagent Kit Guide. Let the dye warm up to room temperature for 30 minutes and vortex for 10 seconds before preparing the gel-dye mix. Protect the dye from light during this time. After centrifugation, the freshly prepared gel-dye should be taken up from the top of the tube.

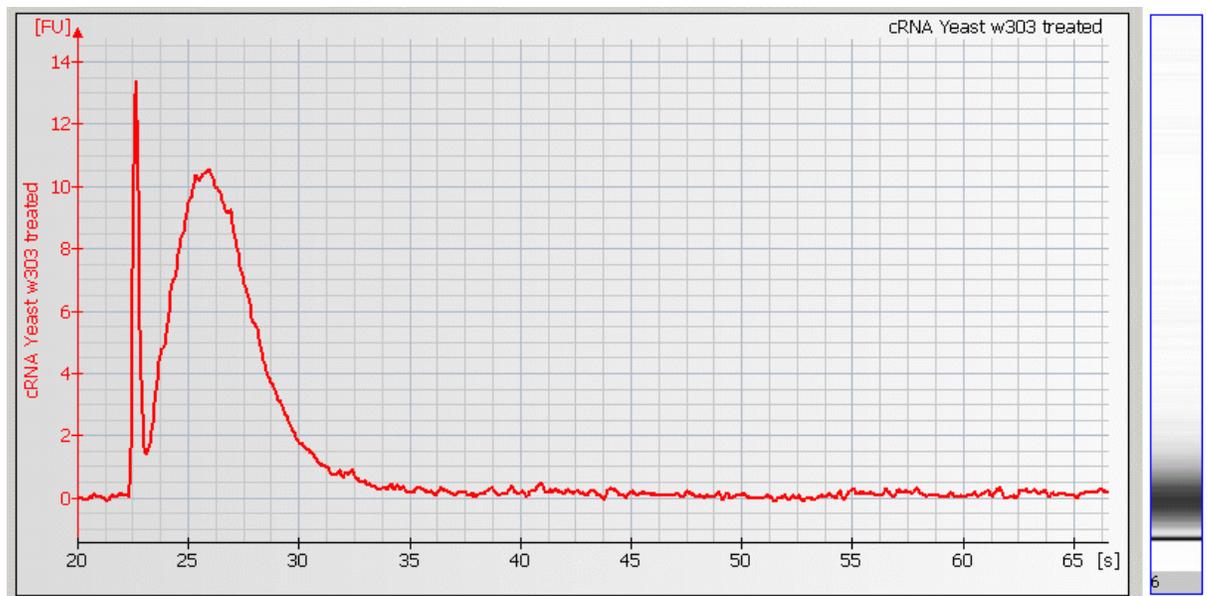
Causes for Degraded RNA Ladder and/or Samples

Most Probable Causes	Solution
RNase contamination of the pin-set.	Decontaminate the pin-set. Follow decontamination procedure, see “ How to clean the Pin Set of the Electrode Cartridge ” on page 192.
RNase contamination of chips and/or reagents.	Use a new chip and/or fresh reagents. Wear powder-free gloves when preparing the chip.

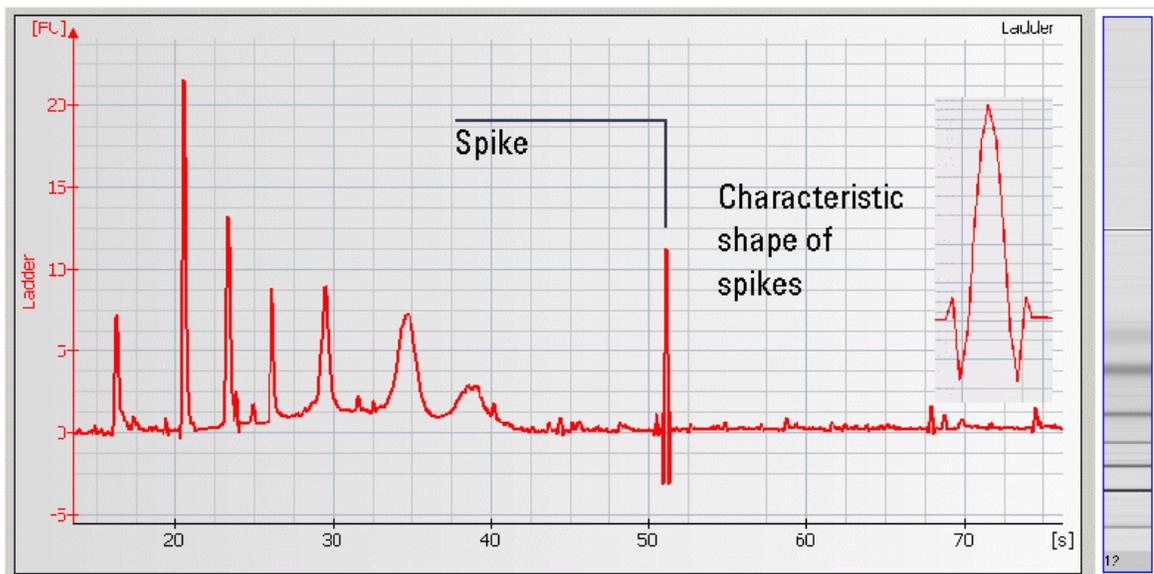
Causes for Spikes

Most Probable Causes	Solution
Vibration of Agilent 2100 bioanalyzer.	Don't touch Agilent 2100 bioanalyzer during a run. Remove vibration devices, such as vortexers and vacuum pumps, from bench.
Particles in tubes.	For reagent preparation, use tubes that are supplied with the kit. Do not use autoclaved tubes.
Chip/gel-dye mix contaminated.	Prepare new chip with new gel-dye mix: Wear powder-free gloves only. Don't touch the underside of the chip. Don't touch the wells of the chip. Clean the electrodes. Load the chip immediately after taking it out of its sealed bag.

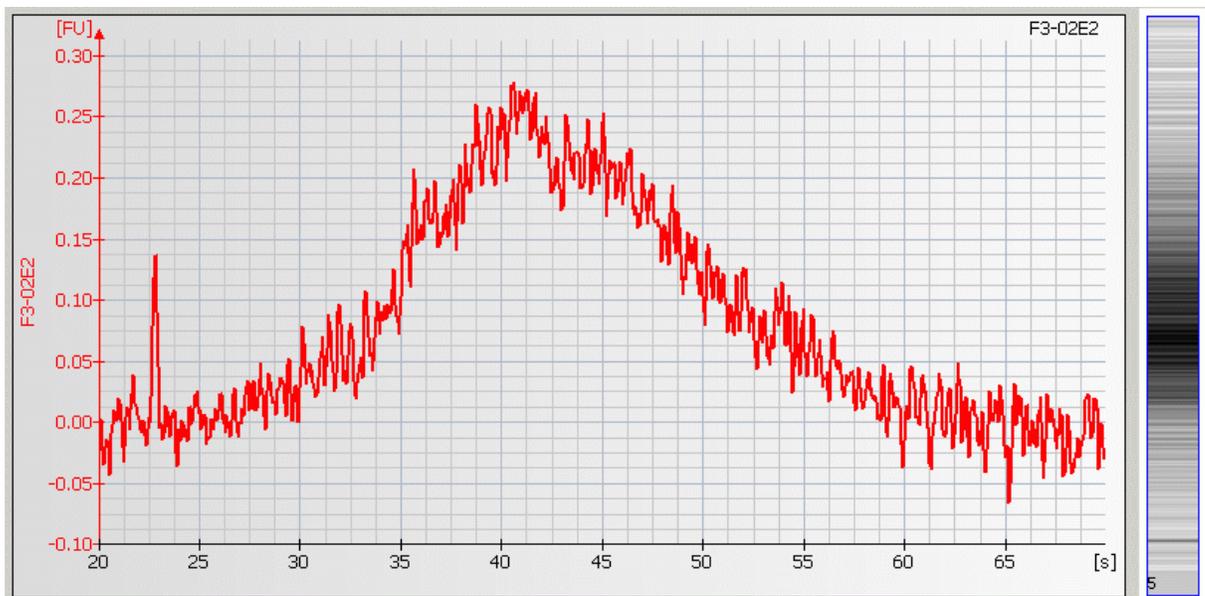
Causes for Low Sensitivity

Most Probable Causes	Solution
Gel-dye mix expired.	Use prepared gel-dye mix within one day.
Dye concentration too low.	Use dye concentration according to the Reagent Kit Guide. Let the dye warm up to room temperature for 30 minutes before preparing the gel-dye mix. Protect the dye from light during this time.
Pipetting error during preparation of mixtures.	Check dilution procedure and calibration of pipette.
Chip pipetting error.	Pipette new chip. Always insert the pipette tip to the bottom of the well when dispensing the liquid. Use appropriate pipette and tips.
Probable Causes	Solution
Fingerprint on focusing lens or on the backside of the chip.	Clean lens as described in “Cleaning the Lens” on page 222. Do not touch the underside of the chip
Insufficient vortexing of chip.	Vortex chip for 1 minute. Only use IKA shaker for chip vortexing. Adjust speed to set-point (2400 rpm).

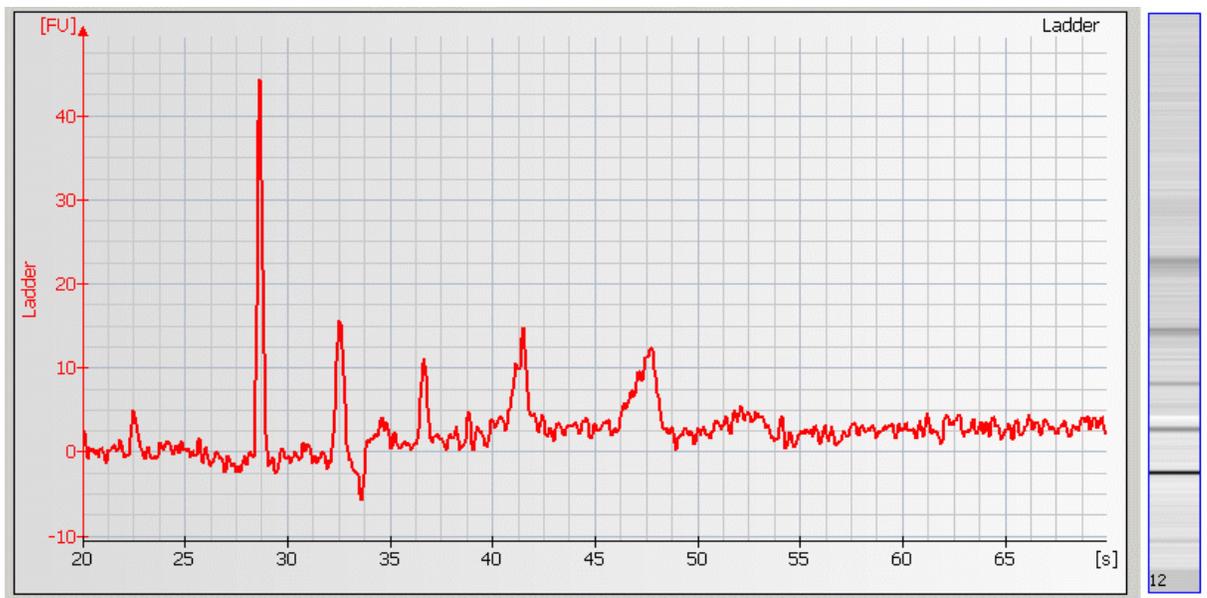
Causes for Baseline Noise

Most Probable Causes	Solution
Fingerprint on focusing lens or on the backside of the chip.	Clean lens as described in “Cleaning the Lens” on page 222. Do not touch the underside of the chip
Chip contaminated.	Wear powder-free gloves only. Don't touch the underside of the chip. Don't touch the wells of the chip. Clean the electrodes. Load the chip immediately after taking it out of its sealed bag.
Vibration of Agilent 2100 bioanalyzer.	Don't touch Agilent 2100 bioanalyzer during a run. Remove vibration devices, such as vortexers and vacuum pumps, from bench.
Probable Causes	Solution
Dye concentration too low.	Use dye concentration according to the RNA Reagent Kit Guide. Let the dye warm up to room temperature for 30 minutes before preparing the gel-dye mix. Protect the dye from light during this time.

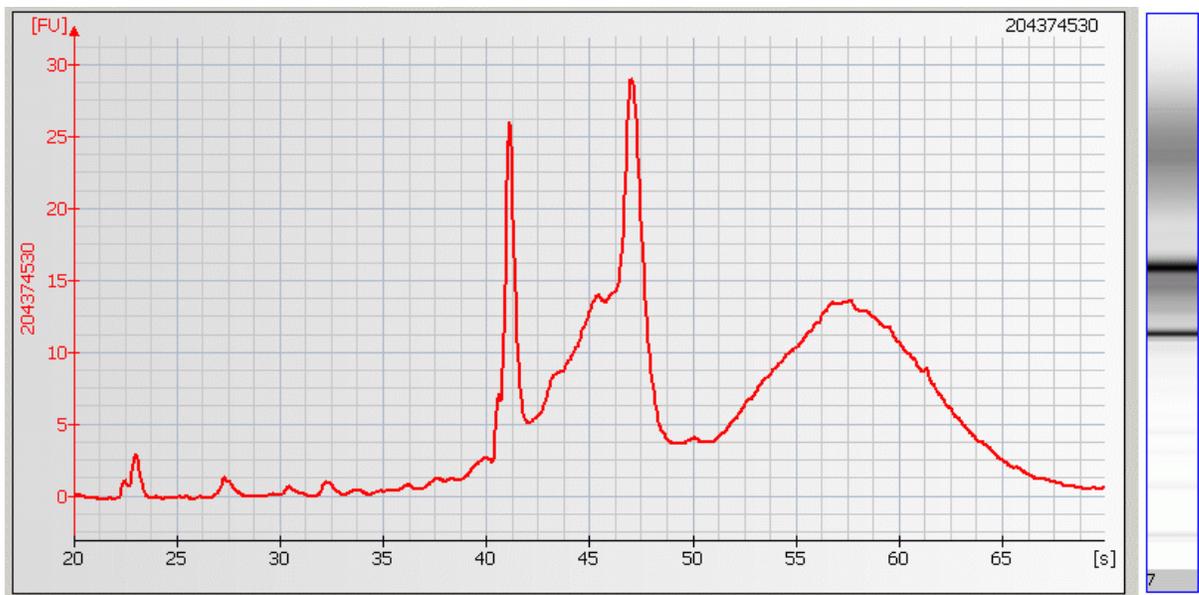
Causes for Broad Peaks

Most Probable Causes	Solution
Sample contaminated with genomic DNA.	Check RNA-isolation protocol. To remove genomic DNA, perform DNase treatment.
Leaks currents due to contaminated pin-set.	Clean the pin-set of the electrode cartridge. Follow cleaning procedure, see “How to clean the Pin Set of the Electrode Cartridge” on page 192
Electrodes contaminated with RNases.	Clean electrodes with RNaseZAP. Follow cleaning procedure, see “How to clean the Pin Set of the Electrode Cartridge” on page 192
Probable Causes	Solution
Clogged gasket and plastic adapter of priming station	Check the priming station as described in “Checking the Chip Priming Station for Proper Performance - Seal Test” on page 209. Clean/replace gasket and plastic adapter if necessary.
Wrong settings of chip priming station.	Check if clip and base plate of priming station are in the right position (see RNA Reagent Kit Guide).

Least Probable Causes	Solution
Dye concentration too high.	Use dye concentration according to the Reagent Kit Guide. Let the dye warm up to room temperature for 30 minutes before preparing the gel-dye mix. Protect the dye from light during this time.

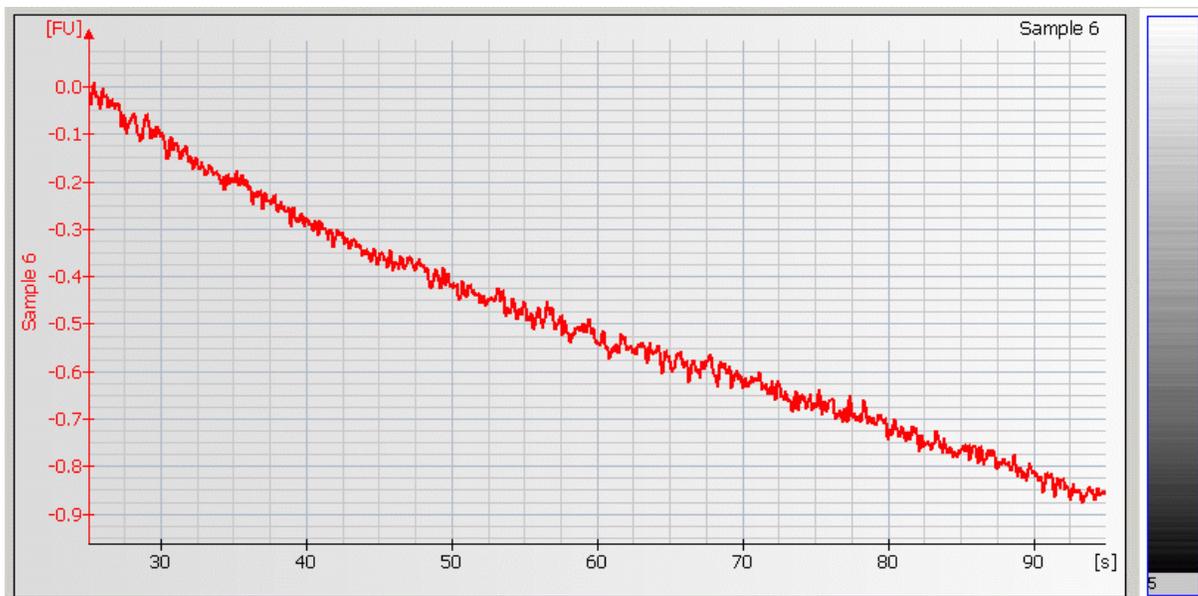
Causes for Missing Peaks

Most Probable Causes	Solution
Too high salt concentration in sample	Refer to the maximum sample buffer salt concentration as specified in the reagent kit guide. Dilute samples with deionized RNase free water if necessary.
Clogged gasket and plastic adapter of priming station	Check chip priming station as described in “Checking the Chip Priming Station for Proper Performance - Seal Test” on page 209). Clean/replace gasket and plastic adapter if necessary.
Wrong settings of the chip priming station.	Check if clip and base plate of priming station are in the right position (see Reagent Kit Guide).
Leak current due to contaminated electrodes or wet chip surface (detergents in RNA elution buffer)	Clean electrodes with analysis-grade water and a toothbrush, see “How to clean the Pin Set of the Electrode Cartridge” on page 192. Prepare a new chip. Lower vortexing speed or mix samples manually

Probable Causes	Solution
Laser broken.	Perform Laser/LED/Optics test and Autofocus test as described in “ Hardware Diagnostics ” on page 33. If tests fail contact Agilent Technologies.
Least Probable Causes	Solution
Autofocus failure or high voltage power supply defective	Check autofocus and high voltage power supply by means of the “ Hardware Diagnostics ” on page 33. If diagnostic fails, contact Agilent Technologies.
Sample wells filled with water.	Refer to the Reagent Kit Guide for proper preparation of the chip.

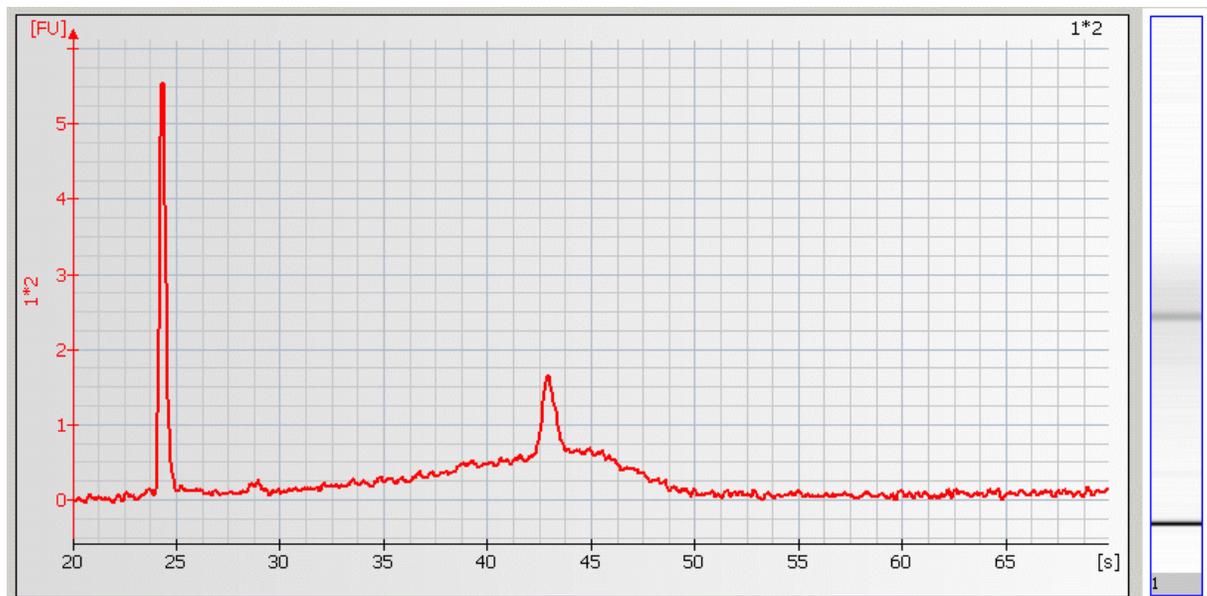
Causes for Missing RNA Fragment

Most Probable Causes	Solution
Too high salt concentration in sample.	Refer to the maximum sample buffer salt concentration as specified in the reagent kit guide, Dilute samples with deionized RNase free water if necessary,
Probable Causes	Solution
Sample degradation because of RNase-contamination of electrodes or reagents.	Clean electrodes with RNaseZAP. Follow cleaning procedure, see “How to clean the Pin Set of the Electrode Cartridge” on page 192. Use a new chip and/or fresh reagents. Wear powder-free gloves when preparing the chip.
Incompatible column material of RNA extraction kit.	Use RNA extraction kit of different vendor.

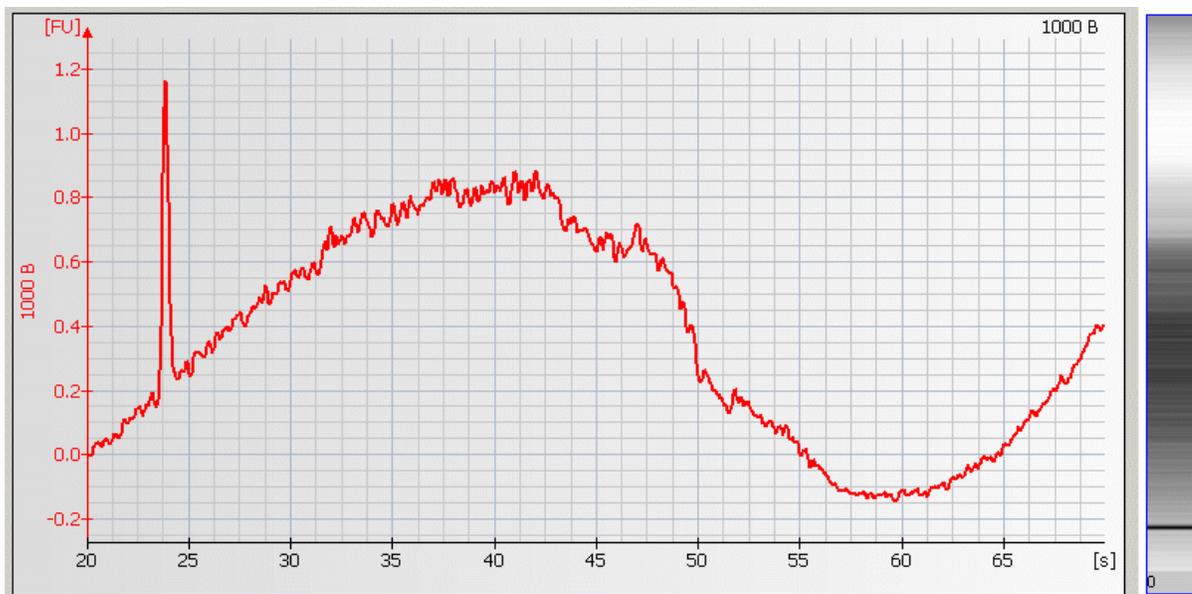
Causes for Wavy Baseline

Most Probable Causes	Solution
Following sample contaminated with genomic DNA causes baseline fluctuations.	Check RNA-isolation protocol. To remove genomic DNA, perform DNase treatment.
Leak current due to contaminated electrodes or wet chip surface (detergents in RNA elution buffer).	Clean electrodes with analysis-grade water and a toothbrush, see “How to clean the Pin Set of the Electrode Cartridge” on page 192. Prepare a new chip. Lower vortexing speed or mix samples manually
Clogged gasket and plastic adapter of priming station	Check chip priming station as described in “Checking the Chip Priming Station for Proper Performance - Seal Test” on page 209). Clean/replace gasket and plastic adapter if necessary.
Contaminated electrode cartridge.	Clean the electrode cartridge as described in “RNA Nano Assay” on page 184 or “RNA Pico Assay” on page 188.

Probable Causes	Solution
Wrong settings of the chip priming station.	Check if clip and base plate of priming station are in the right position (see Reagent Kit Guide).
Least Probable Causes	Solution
Autofocus failure or high voltage power supply defective	Check autofocus and high voltage power supply by means of the “ Hardware Diagnostics ” on page 33. If diagnostic fails, contact Agilent Technologies.
