Agilent 2100 Bioanalyzer Maintenance and Troubleshooting Guide

Edition November 2003

Manual Part number: G2946-90001

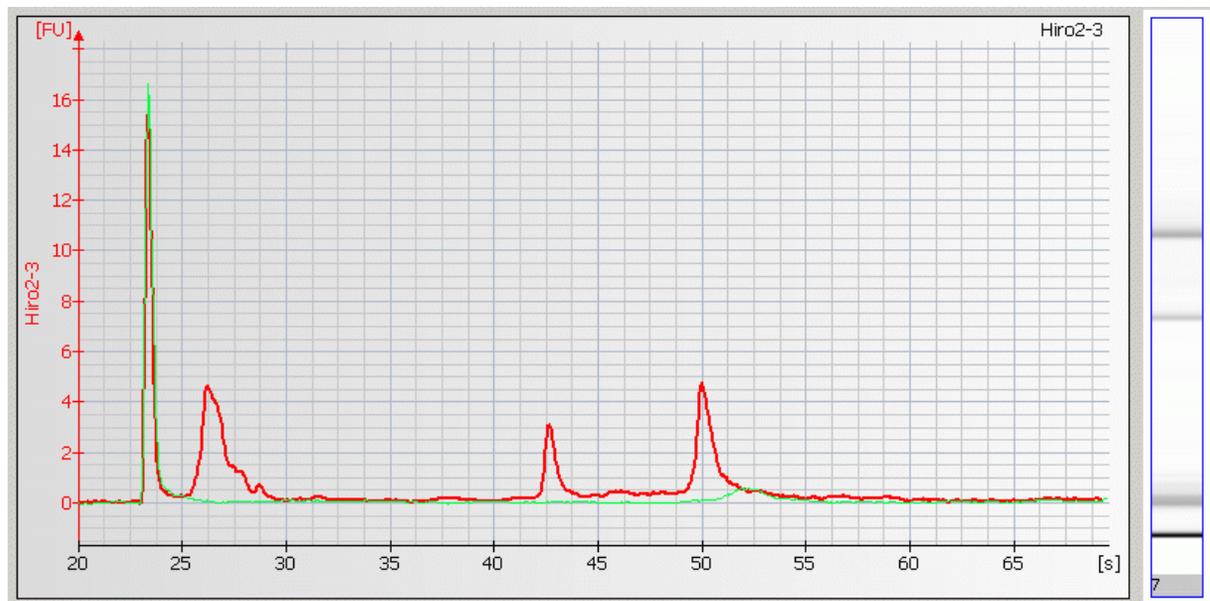
Causes for Cross Contamination

Most Probable Causes	Solution
Contamination of pipette tips.	Use fresh tips for each pipetting step.
Contamination of electrodes.	Clean electrodes between runs like described in " Maintenance of the Electrode Cartridge " on page 180.
Least Probable Causes	Solution
Leaks currents due to contaminated pin-set.	Clean the pin-set of the electrode cartridge. Follow cleaning procedure, see " How to clean the Pin Set of the Electrode Cartridge " on page 192.

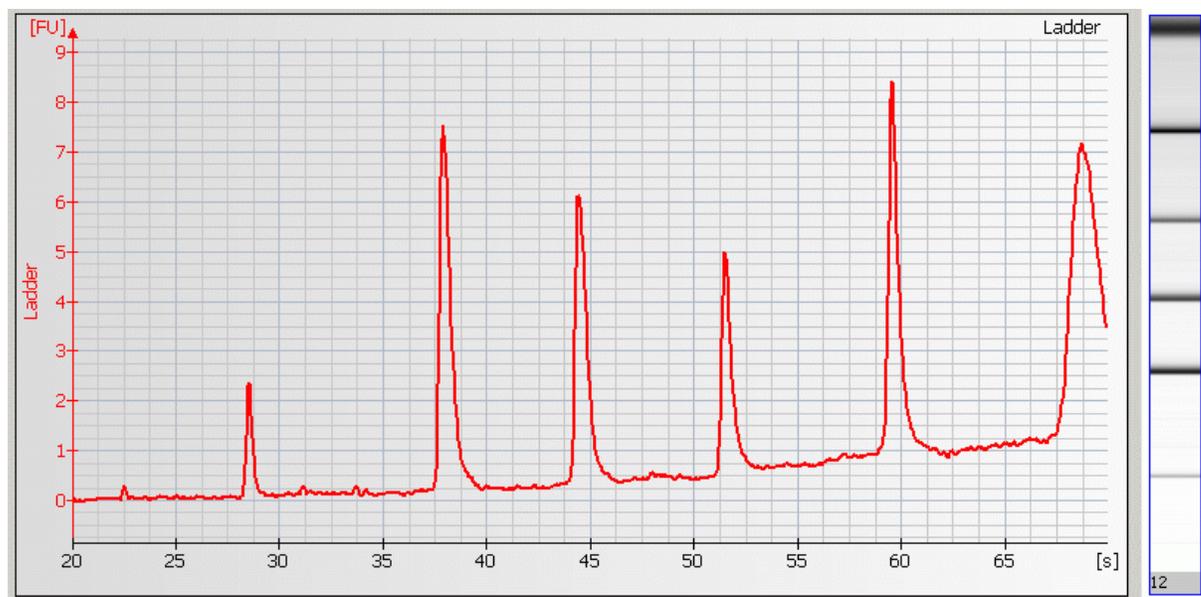
Late Migration of RNA Ladder or Samples

Causes for Late Migration of RNA Ladder or Sample

Most Probable Causes	Solution
Vortex speed too high.	Vortex at lower (medium) speed. For chips use only the IKA vortexer.
Leak current due to dirty electrodes.	Clean electrodes as described in “How to clean the Pin Set of the Electrode Cartridge” on page 192.
Detergents in RNA elution buffer lowers surface tension in wells of chip. This leads to liquid spill on top of the chip during vortexing. As a result leak currents during the run will occur.	Prepare a new chip. Lower vortexing speed or mix samples manually.
Probable Causes	Solution
Vortex adapter not connected tightly.	Press vortex adapter tightly on mount (vortex adapter must not rock). Replace vortex adapter (p/n 5022-2190) as described in “Maintenance of the Vortexer: Changing the Adapter” on page 228.

Probable Causes	Solution
Clogged gasket and plastic adapter of priming station	Check chip priming station as described in “ Checking the Chip Priming Station for Proper Performance - Seal Test ” on page 209). Clean/replace gasket and plastic adapter if necessary.

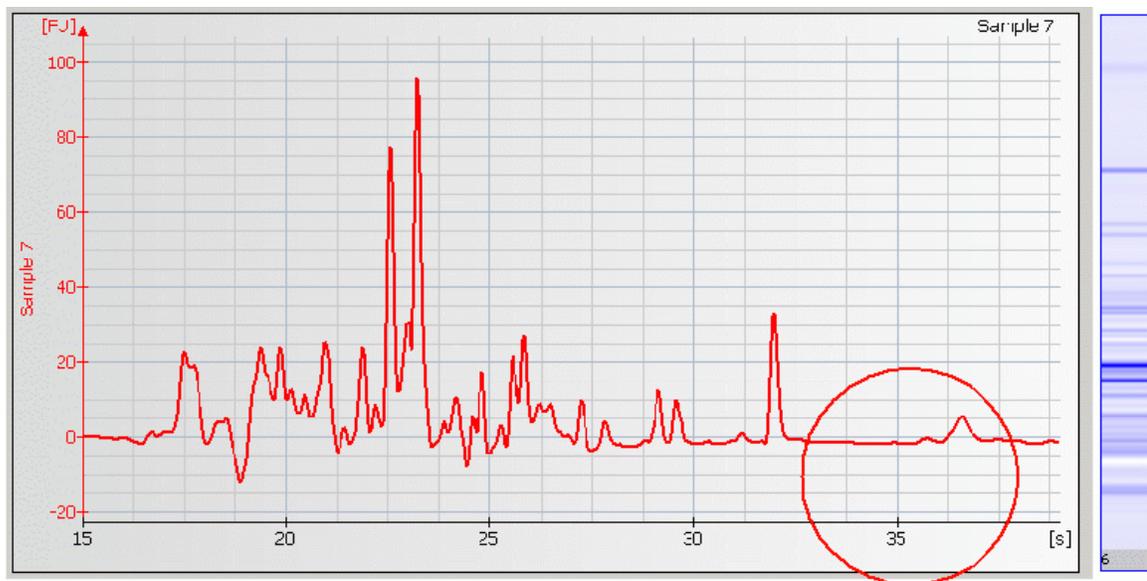
Causes for Short Run Time

Most Probable Causes	Solution
<p>Upper marker in ladder was not correctly assigned due to low intensity of upper marker in the ladder.</p>	<p>To correct for wrong selected upper marker in ladder, set upper marker manually. If necessary, adjust peak find settings. If peaks are detected that are not part of the ladder, exclude them. For better upper marker identification:</p> <p>Turn off the analysis. For correct alignment overlay electropherograms of multiple wells to clearly identify the upper marker. For details please refer to the Online Help or Users Guide.</p> <p>See also “Low or Missing Upper Marker in Ladder” on page 139 for probable causes.</p>

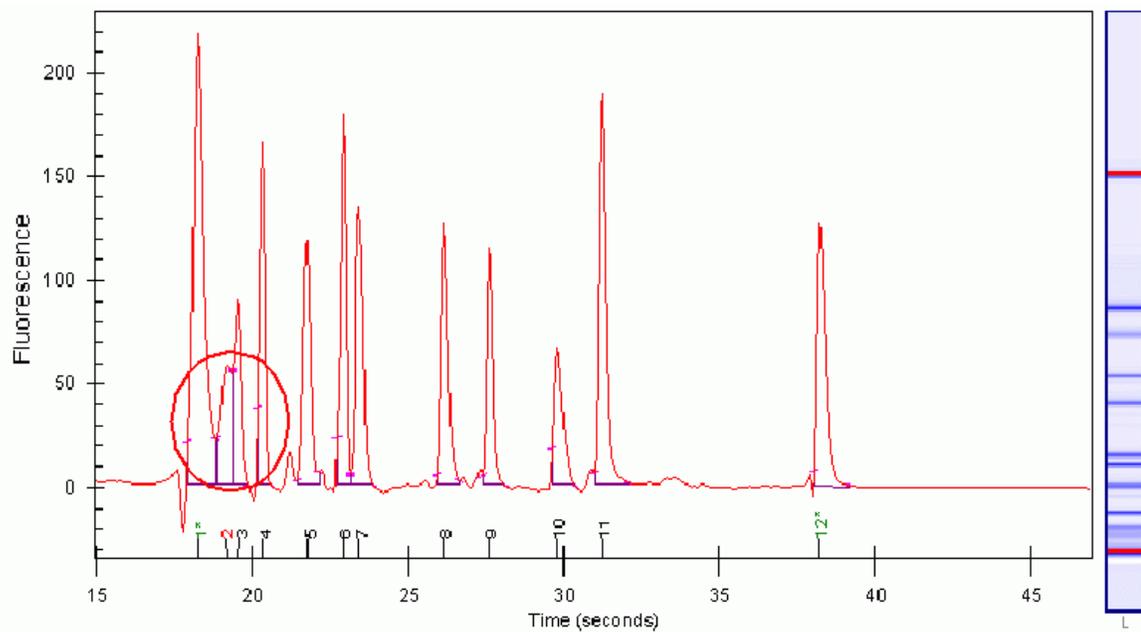
Causes for Additional Sample or Ladder Peaks

Most Probable Causes	Solution
Sample or ladder not denaturated properly.	Use fresh sample aliquot. Heat sample/ denaturating solution and ladder for 5 min at 100 °C
Sample/denaturating solution and/or ladder are dried out during denaturation.	Sample/denaturating solution and/or ladder were denaturated in 1.5 ml tubes. Use 0.5 ml tubes for denaturating
Chip contaminated. Dust particles in separation channels.	Wear powder-free gloves only. Don't touch the wells of the chip. Clean the electrodes: see “How to clean the Pin Set of the Electrode Cartridge” on page 192 for additional information. Load the chip immediately after taking it out of its sealed bag.
Probable Causes	Solution
Ladder degraded.	Refer to the protein reagent kit guide for proper ladder storage. Optional: Prepare ladder aliquots and use a new aliquot.
Vibration of Agilent 2100 bioanalyzer.	Don't touch Agilent 2100 bioanalyzer during a run. Remove vibration devices, such as vortexers and vacuum pumps, from bench.

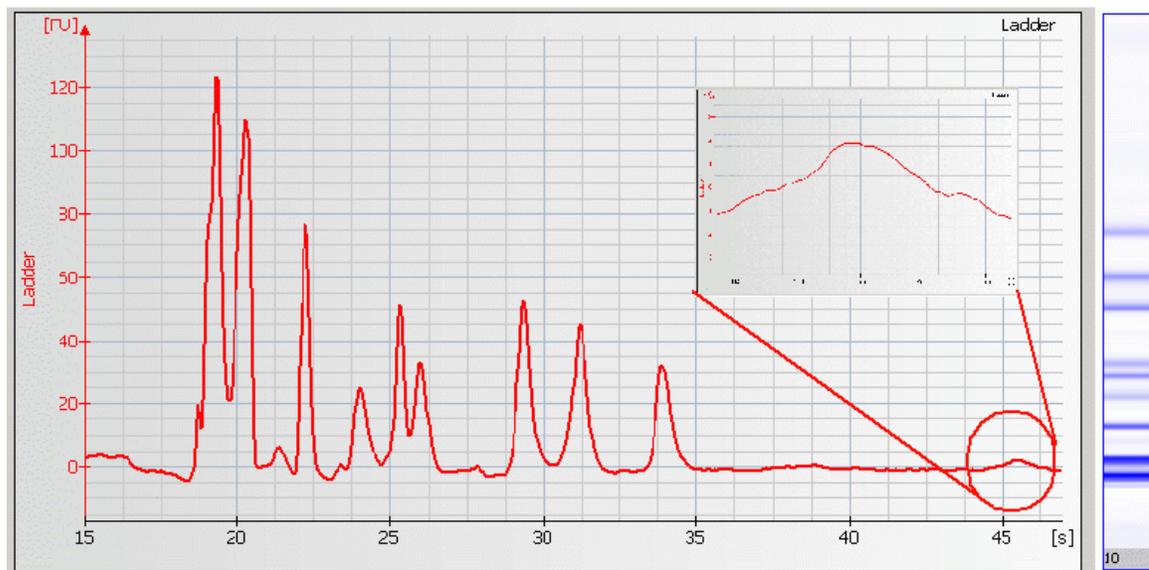
Causes for Low or Missing Upper Marker in Ladder

Most Probable Causes	Solution
Ladder degraded.	<p>For correct ladder storage and denaturation, refer to the protein reagent kit guide. To correct for wrong selected upper marker, set upper marker manually. If necessary, adjust peak find settings. If peaks are detected that are not part of the ladder, exclude them.</p> <p>For better upper marker identification: Turn off the analysis. For correct alignment overlay electropherograms of multiple wells to clearly identify the upper marker. For details please refer to the Online Help or Users Guide.</p>
Diluted ladder is too old.	Use diluted ladder within one day.
Probable Causes	Solution
Ladder not denaturated properly.	Use fresh ladder aliquot. Heat ladder for 5 min at 100 °C
Ladder dried out during denaturation.	Ladder was denaturated in 1.5 ml tubes. Use 0.5 ml tubes for denaturing.

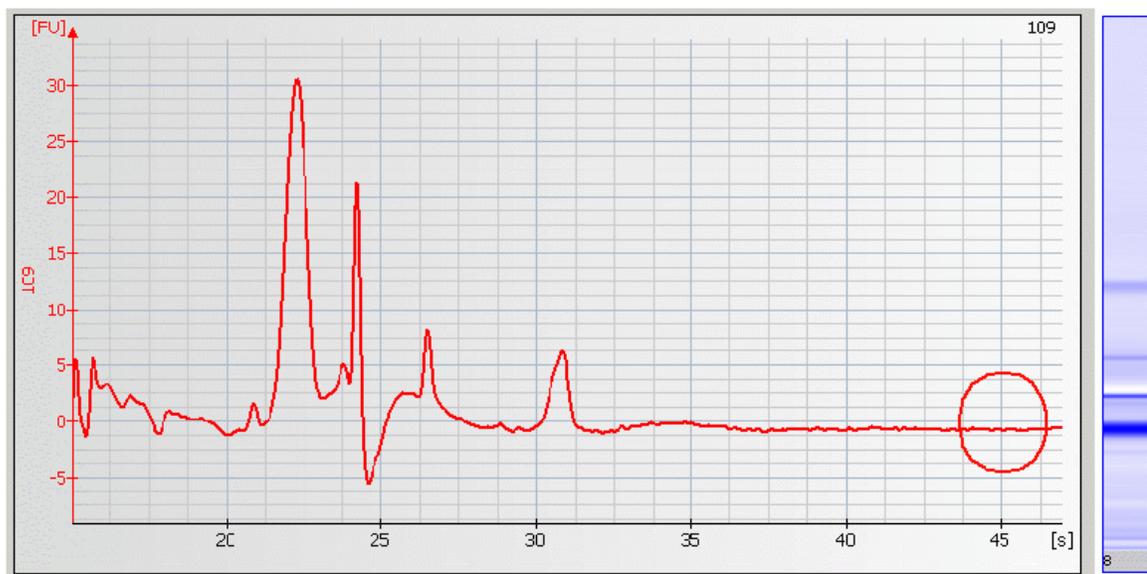
Causes for Low or Missing Upper Marker in Sample

Most Probable Causes	Solution
Sample buffer/denaturing solution not handled according to the instructions.	<p>Refer to the instructions provided with the reagent kit guide for storage and preparation of the sample buffer/denaturing solution. To correct for wrong selected upper marker, set upper marker manually. If necessary, adjust peak find settings.</p> <p>For better upper marker identification: Turn off the analysis. For correct alignment overlay electropherograms of multiple wells to clearly identify the upper marker. For details please refer to the Online Help or Users Guide.</p>
Incompatible sample component. Some components of the buffer, e.g. CHAPS, TFA, etc. interfere with the upper marker and decrease sensitivity.	<p>See protein reagent kit guides for a list of compatible buffers and buffer compounds. For an updated list please refer to the web-site www.agilent.com/chem/labonachip.</p> <p>If necessary dilute, dialyze or desalt the sample. It is recommended to dilute the samples 1:2, 1:4, ... with water to find the optimal dilution.</p>

Probable Causes	Solution
Upper marker was digested by proteases.	Add protease inhibitor cocktails to cell lysate samples.
Samples not denaturated properly.	Use fresh sample aliquot. Heat samples with denaturing solution for 5 min at 100 °C
Samples dried out during denaturation.	Samples were denaturated in 1.5 ml tubes. Use 0.5 ml tubes for denaturing.

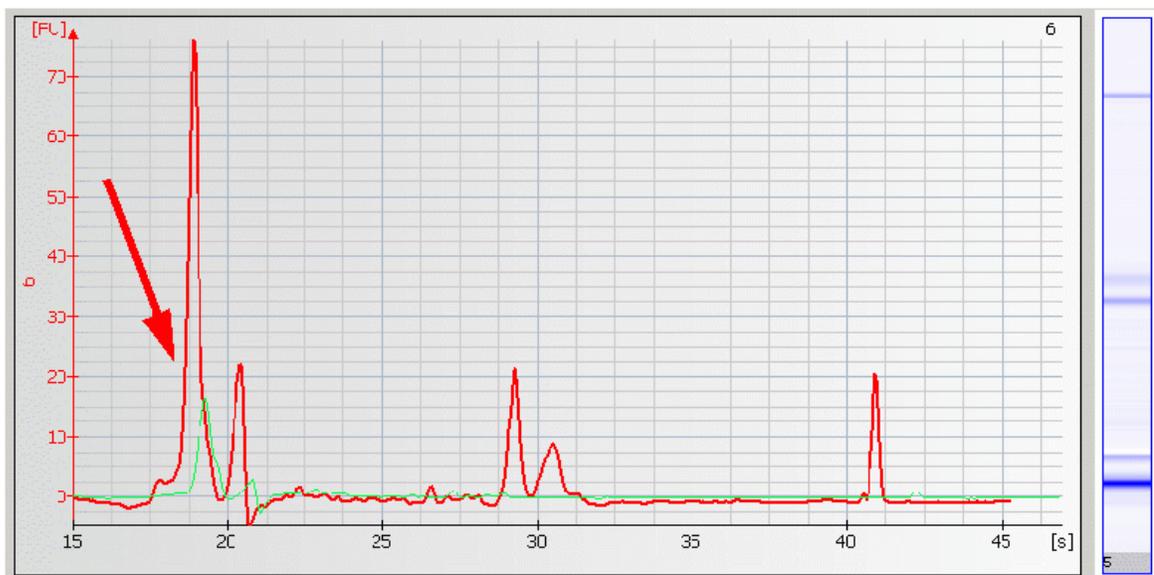
As long as the lower marker is detected, the assay performance is not affected by lower marker or system peak variability.

Causes for High Lower Marker Variability

Most Probable Causes	Solution
<p>Buffer components of the sample , e.g. salts, detergents, other additives etc. interfere with the lower marker.</p> <p>Variability of ionic strength of the sample influence the lower marker intensity.</p>	<p>See protein reagent kit guide for a list of compatible buffers and buffer compounds. For an updated list please refer to the web-site www.agilent.com/chem/labonachip.</p> <p>If necessary dilute, dialyze or desalt the sample. It is recommended to dilute the samples 1:2, 1:4, ... with water to find the optimal dilution.</p>

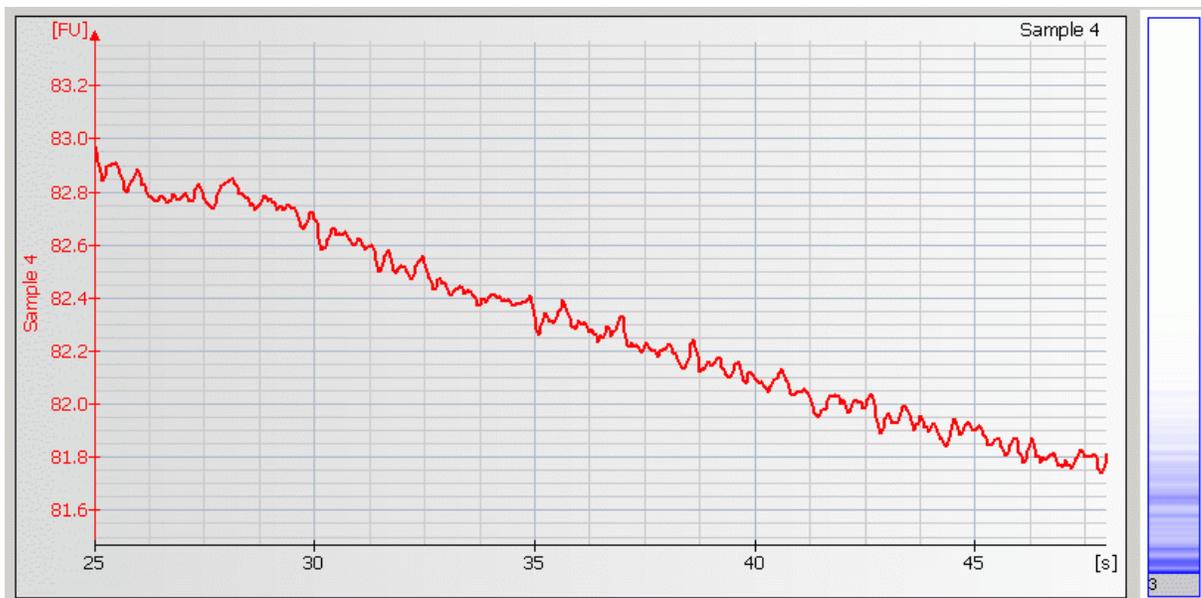
Causes for Missing Peaks

Most Probable Causes	Solution
Laser defective.	Check laser using the “ Hardware Diagnostics ” on page 33. If the laser test fails, contact Agilent Technologies.
Gel dye mix was loaded in the destain well instead of destaining solution.	Discard chip and prepare new chip according to protocol.
Probable Causes	Solution
Autofocus failure.	Check autofocus using the “ Hardware Diagnostics ” on page 33. If autofocus test fails, contact Agilent Technologies.
Least Probable Causes	Solution
High voltage power supply defective.	Check high voltage power supply using the “ Hardware Diagnostics ” on page 33. If the power supply is defective, contact Agilent Technologies.
Fingerprint on focusing lens or on the backside of the chip.	Clean lens as described in “ Cleaning the Lens ” on page 222. Do not touch the underside of the chip

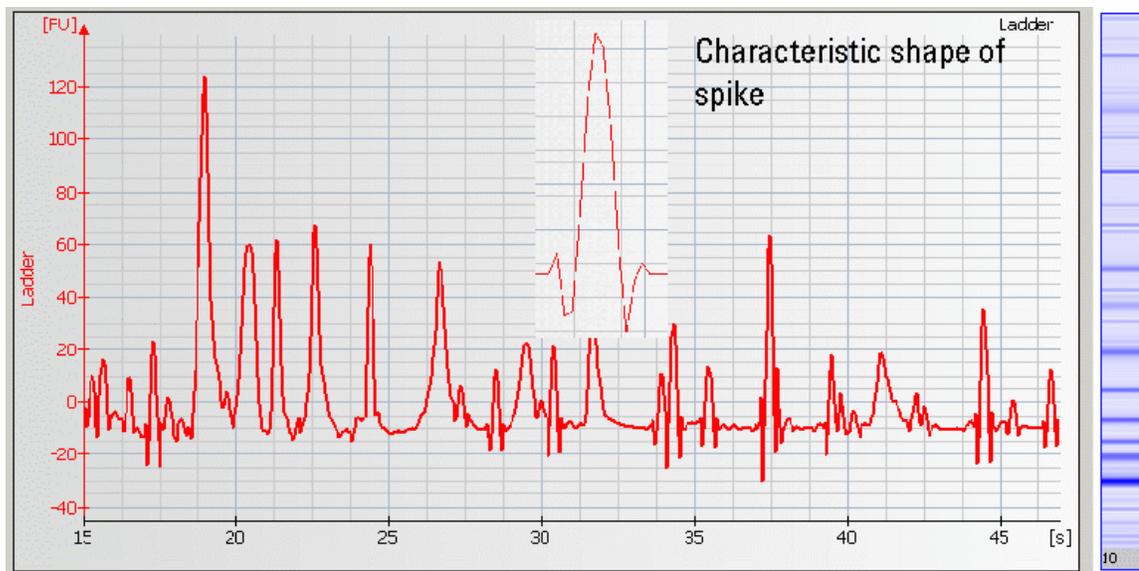
Causes for Spikes

Most Probable Causes	Solution
<p>Chip/gel-dye mix/destaining solution/electrodes contaminated.</p>	<p>Prepare new chip with new gel-dye mix and new destaining solution:</p> <p>Wear powder-free gloves only. Don't touch the underside of the chip. Don't touch the wells of the chip.</p> <p>Clean the electrodes as described in "Maintenance of the Electrode Cartridge" on page 180.</p> <p>Load the chip immediately after taking it out of its sealed bag.</p>
<p>Gel-dye mix/destaining solution not properly prepared.</p>	<p>Refer to the reagent kit guide for proper preparation of the gel-dye mix and destaining solution. Let the dye warm up to room temperature for 30 min before preparing the gel-dye mix. Protect the dye from light during this time</p>

Probable Causes	Solution
Vibration of Agilent 2100 bioanalyzer.	Don't touch Agilent 2100 bioanalyzer during a run. Remove vibration devices, such as vortexers and vacuum pumps, from bench.

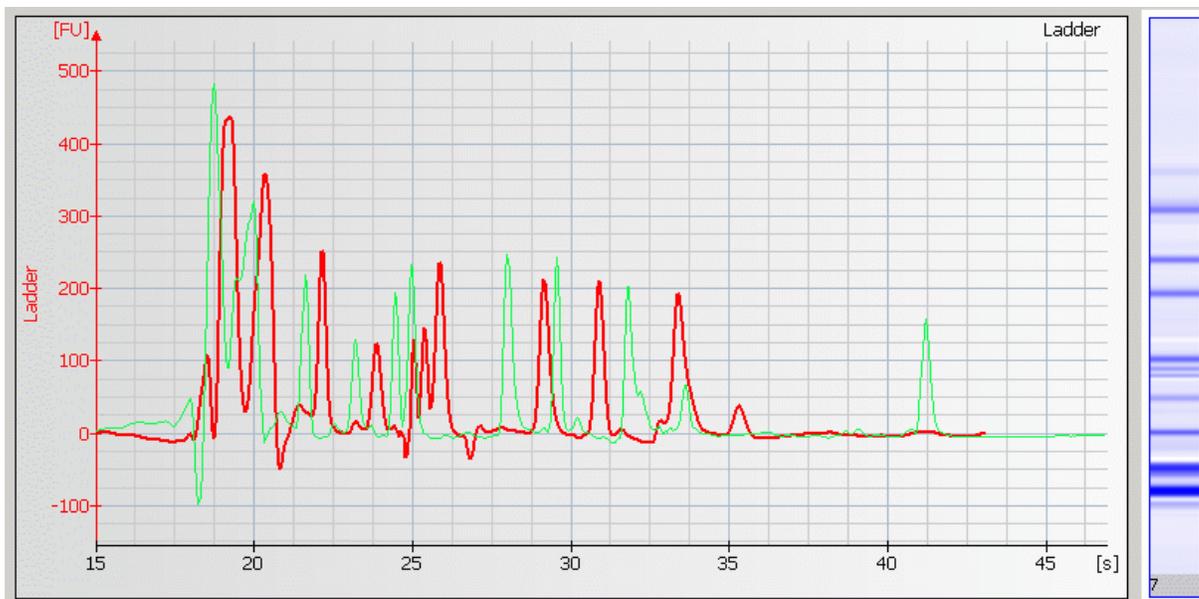
Causes for Poor Reproducibility

Most Probable Causes	Solution
Wrong peak alignment.	Check if alignment is correct. For better identification of the lower and upper marker: Turn off the analysis. For correct alignment overlay electropherograms of multiple wells to clearly identify the lower and upper marker. For further information, please refer to the Online Help or Users Guide.
One or more samples not denaturated properly.	Use fresh sample aliquot. Heat samples with denaturing solution for 5 min at 100 °C
One or more sample dried out during denaturation.	Samples were denaturated in 1.5 ml tubes. Use 0.5 ml tubes for denaturing.
Reducing agent (BME or DTT) was added in one sample and not in the other.	Refer to the reagent kit guide for proper sample reduction.
Dirty electrodes.	Thoroughly clean the electrodes as described " Maintenance of the Electrode Cartridge " on page 180.

Probable Causes	Solution
Diluted samples are too old.	Use diluted samples within one day.
Incompatible buffer component.	<p>See protein reagent kit guide for a list of compatible buffers and buffer compounds. For an updated list please refer to the web-site www.agilent.com/chem/labonachip.</p> <p>If necessary dilute, dialyze or desalt the sample.</p>
Samples were not mixed properly after sample buffer and water and water was added.	Stick to the protocol as described in the reagent kit guide.
Samples were not centrifuged after denaturation	After denaturation step, spin down samples.

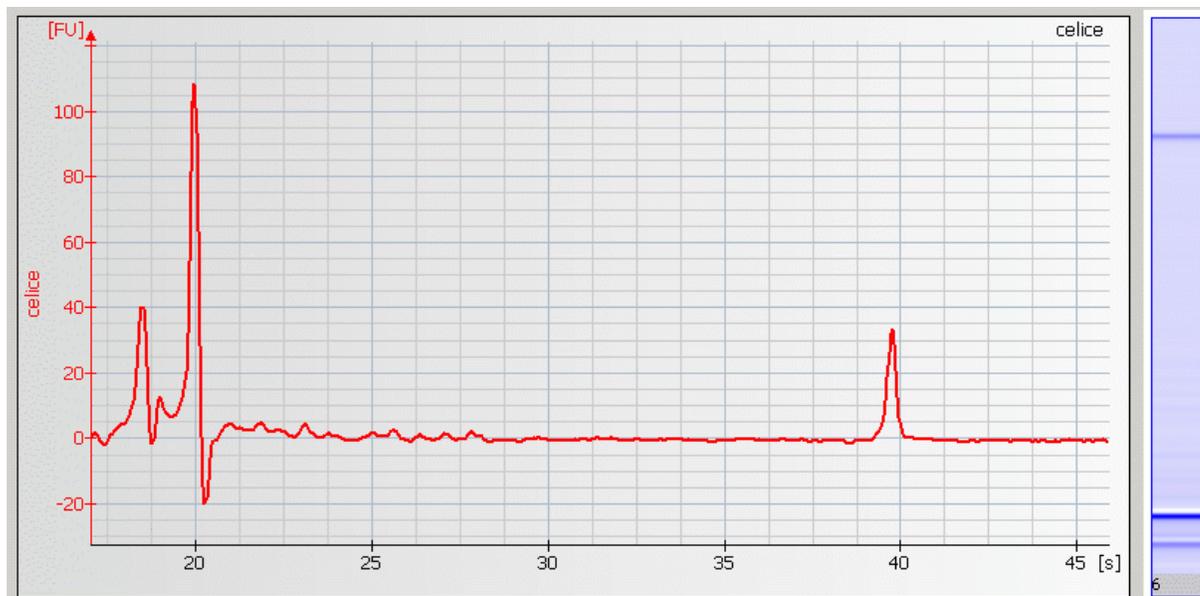
Causes for Low Sensitivity

Most Probable Causes	Solution
Protein concentration in samples too low.	Use protein concentration according to specifications given in the reagent kit guide.
Too high salt concentration in samples.	Sensitivity is strongly affected by salt concentration. Dilute samples in deionized H ₂ O, dialyze samples against low salt buffer or desalt samples using spin filters.
SDS not completely dissolved in dye concentrate.	Let dye concentrate equilibrate to room temperature for 30 min before use. Protect dye concentrate from light during this time. Check for undissolved SDS crystals in the tube. Vortex dye concentrate well before use. If necessary heat the sample buffer to 37 °C for 2 min.
Samples were not diluted prior to chip loading	Dilute samples according to protocol given in the reagent kit guide.

Probable Causes	Solution
Samples not completely denatured.	Use fresh sample aliquot. Heat sample/ denaturing solution for 5 min at 100 °C.
Sample/denaturing solution are dried out.	Sample/denaturing solution were denatured in 1.5 ml tubes. Use 0.5 ml tubes for denaturing.
Pipetting error during preparation of mixtures.	Check dilution procedure and check calibration of pipette.
Least Probable Causes	Solution
Samples dissolved in acidic buffer.	Neutralize samples with appropriate buffer or dilute samples in deionized H ₂ O. Alternatively dialyze samples against buffer with medium pH.

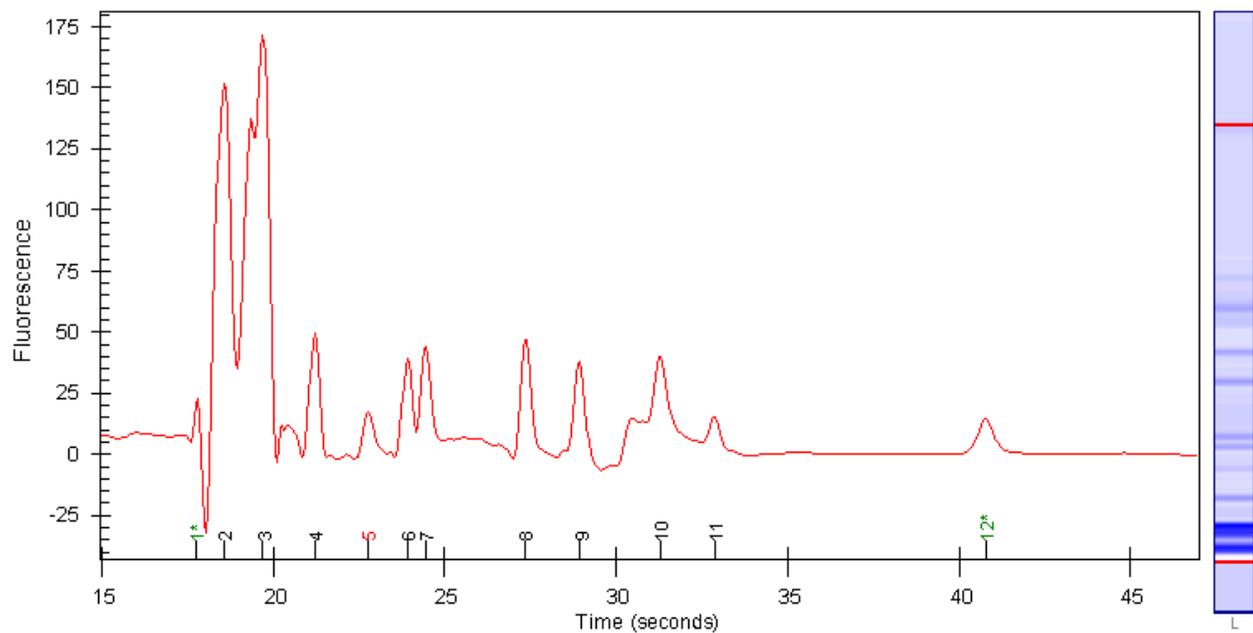
Causes for Low Ladder Peaks

Most Probable Causes	Solution
Ladder degraded.	Refer to the protein reagent kit guide for proper ladder storage. Optional: Prepare ladder aliquots and use a new aliquot.
Ladder not diluted after denaturation.	Refer to the Reagent Kit Guide for proper chip preparation.
Probable Causes	Solution
Ladder not completely denaturated.	Use fresh ladder aliquot. Heat ladder for 5 min at 100 °C.
Ladder dried out.	Ladder was denaturated in 1.5 ml tubes. Use 0.5 ml tubes for denaturating.
Diluted ladder is too old.	Use diluted ladder within one day.
Pipetting error during preparation of mixtures.	Check dilution procedure and calibration of pipette.

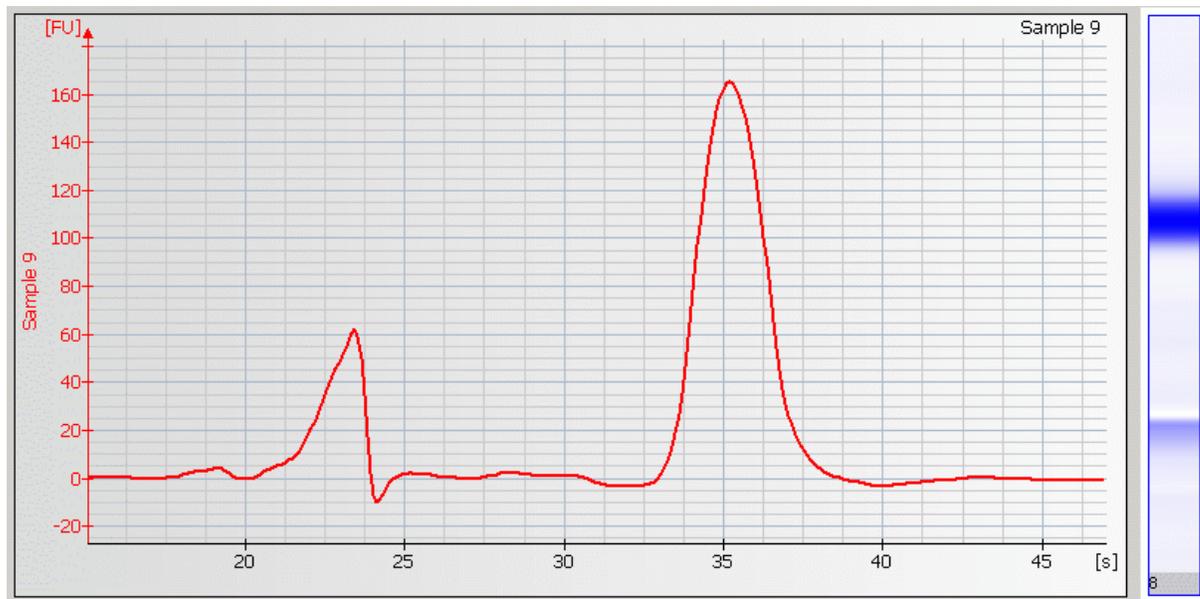
Causes for Broad Peaks

Most Probable Causes	Solution
Wrong peak alignment.	<p>Check if alignment is correct (wrong alignment might cause broad peaks compared to the rest of the chip).</p> <p>For better identification of the lower and upper marker: Turn off the analysis. For correct alignment overlay electropherograms of multiple wells to clearly identify the lower and upper marker. For further information, please refer to the Online Help or Users Guide.</p>
Air bubbles in the bottom of the well.	<p>Always insert the pipette tip to the bottom of the well when dispensing the liquid. Remove large air bubbles with a pipette tip (small bubbles on top of well do not affect the assay).</p>

Probable Causes	Solution
Sample was not denaturated properly.	Use fresh sample aliquot. Heat sample/ denaturing solution for 5 min at 100 °C.
Reducing agent (BME or DTT) was added in one sample and not in the other.	Refer to the reagent kit guide for proper sample reduction.

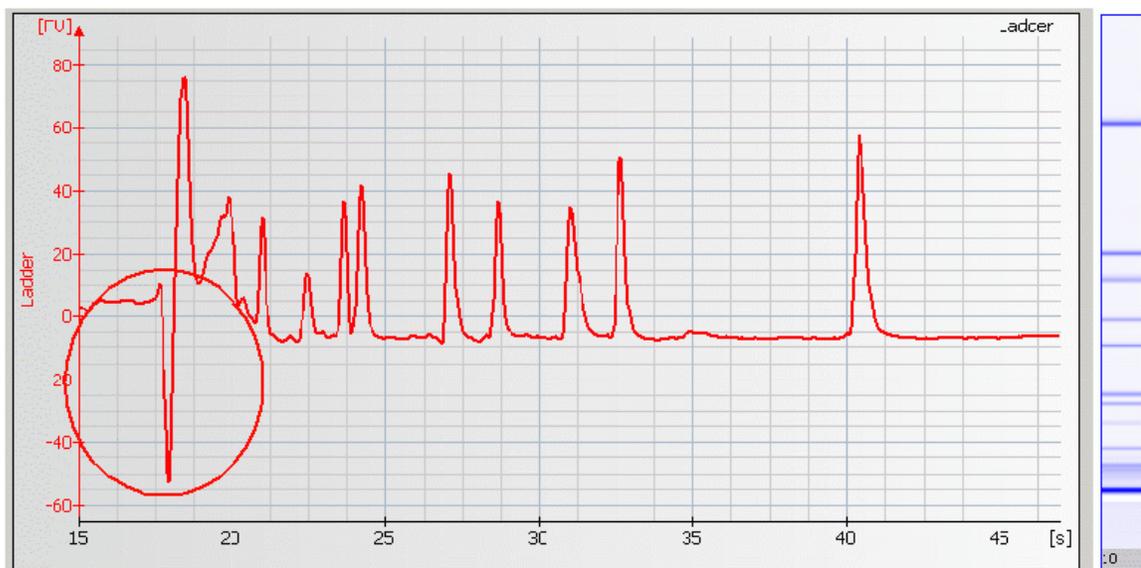
As long as the lower marker is detected, the assay performance is not affected by dips.

Causes for Baseline Dips

Most Probable Causes	Solution
Sample contains additional detergents and/or dyes.	See protein reagent kit guide for a list of compatible buffers and buffer compounds. For an updated list please refer to the web-site www.agilent.com/chem/labonachip . If necessary dilute, dialyze or desalt the sample.

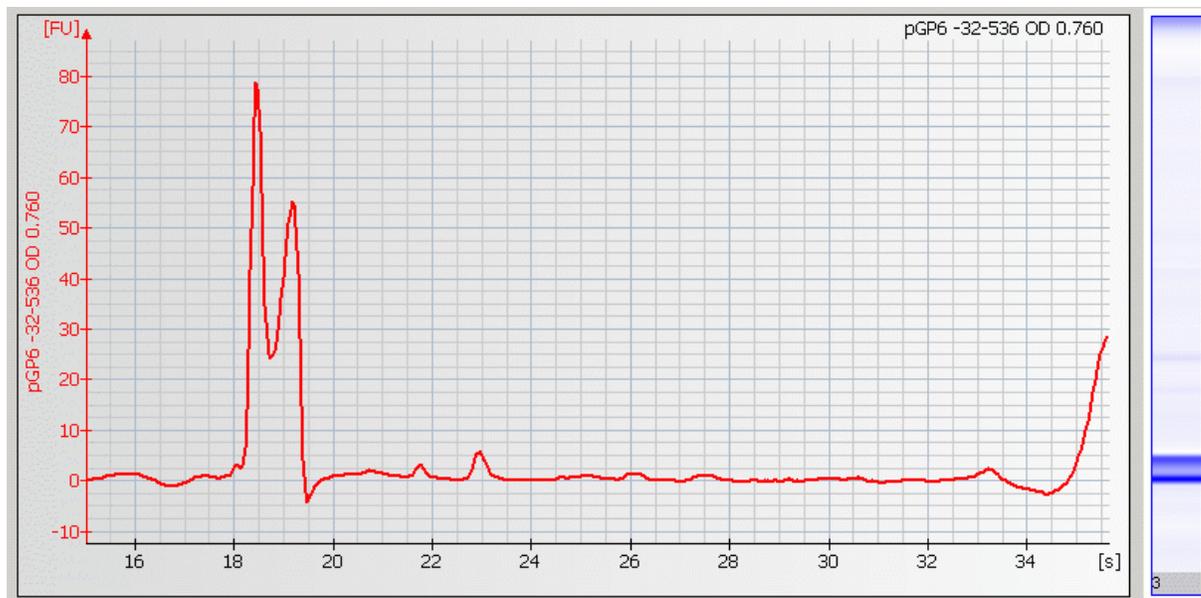
Causes for Late Migration

Most Probable Causes	Solution
Protein chips expired	Check expiration date on chip box.
Protein concentration in samples too high.	Use protein concentration according to specifications given in the reagent kit guide.
Chip not properly primed. Clogged chip priming station or wrong settings of priming station.	Prepare a new chip. Check chip priming station as described in " Checking the Chip Priming Station for Proper Performance - Seal Test " on page 209. Clean/replace gasket and plastic adapter if necessary. Check if clip and base plate of priming station are in the correct position (see protein reagent kit guide)
Least Probable Causes	Solution
Defect Heater Plate	Run the temperature test by using the " Hardware Diagnostics " on page 33. If the heater plate is defective, contact Agilent Technologies.

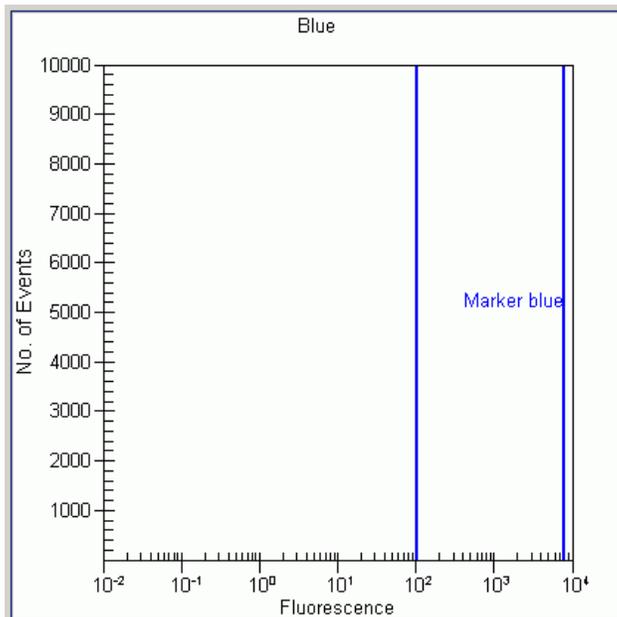
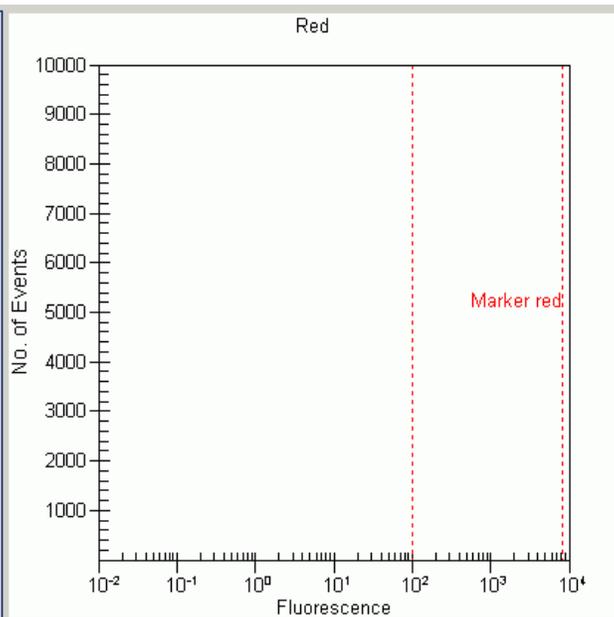
Marker	Min	Max	#Events	%Total	% of gated
▶	● All Events	0	0	0	0	0

Marker	Min	Max	#Events	%Total	% of gated

Causes for No Cell Events

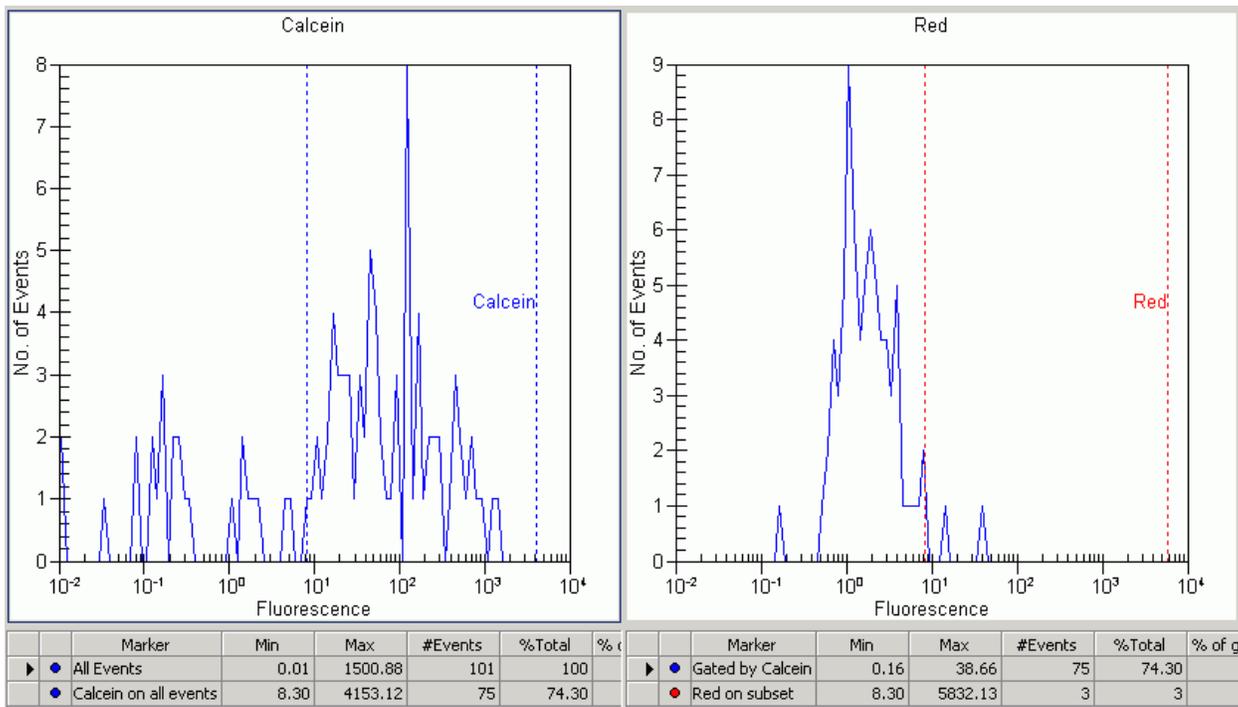
At the recommended cell concentration of 2 million/ml, an average of 750 cells are measured per sample. Event numbers below 400 are considered as low.

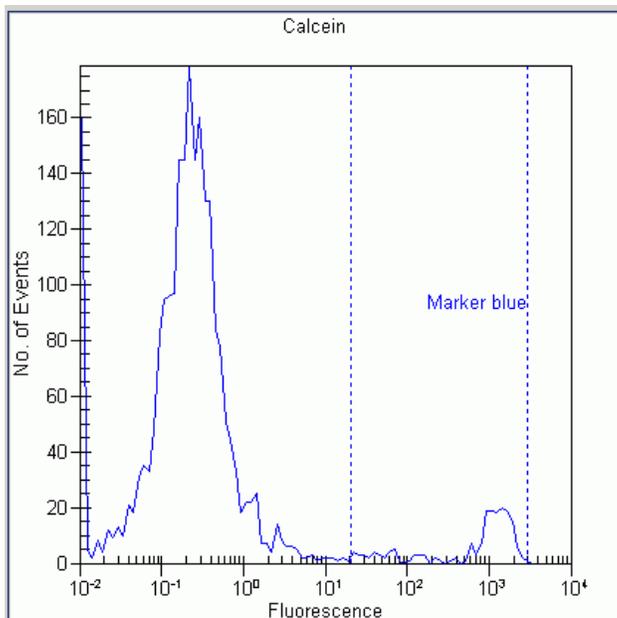
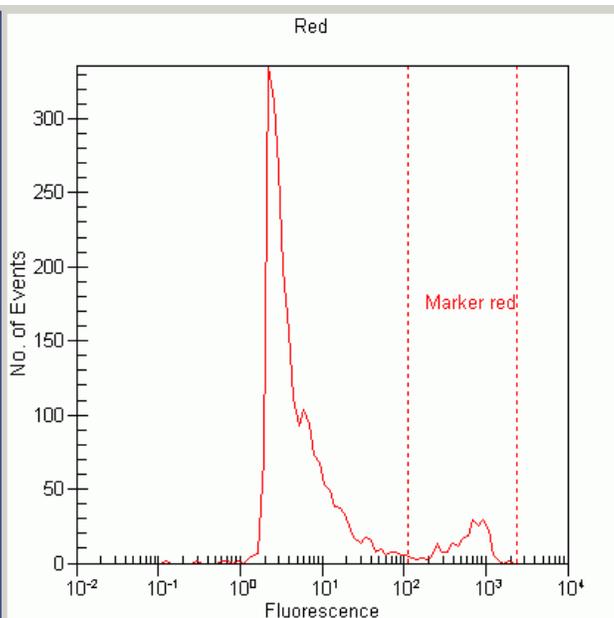
Low Sensitivity

Marker	Min	Max	#Events	%Total
▶	● All Events	0.01	2829.89	2450	100
▶	● Marker blue on all events	20.20	2891.20	185	7.60

Marker	Min	Max	#Events	%Total
▶	● All Events	0.13	1915.89	2450	100
▶	● Marker red on all events	110.13	2351.03	212	8.70

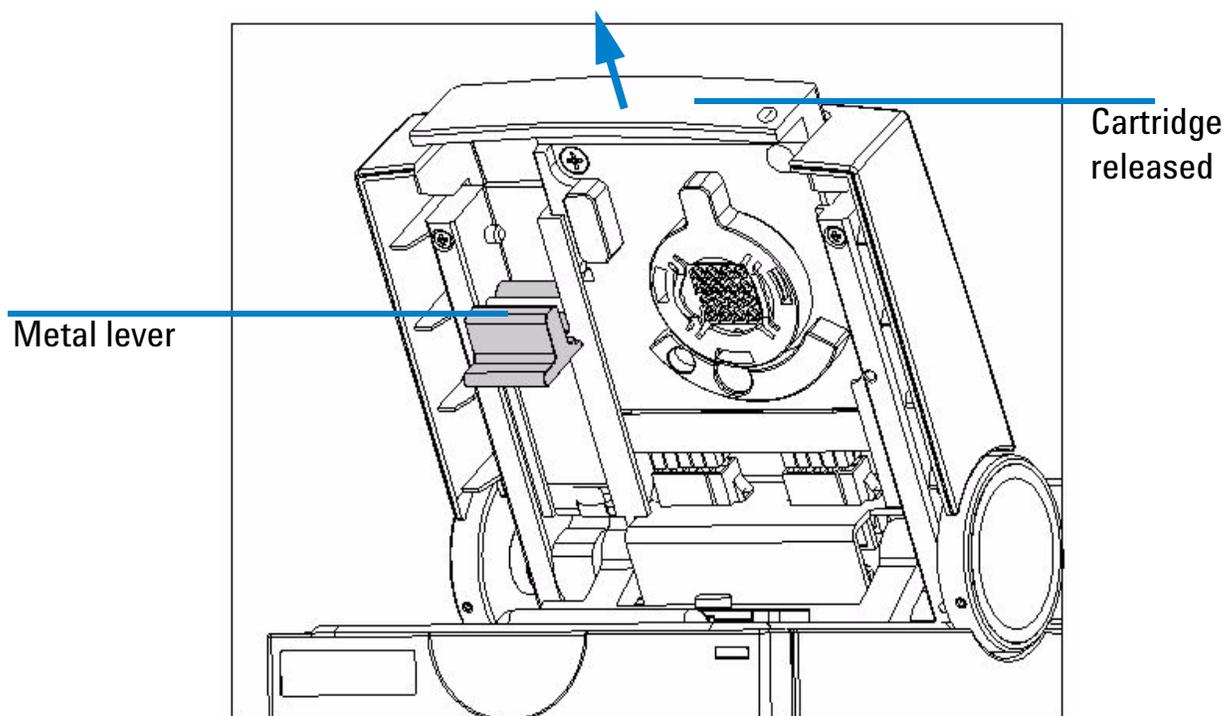
Figure 3 Removing the Electrode Cartridge

- 1 Turn off line power to the 2100 bioanalyzer. The line switch is located at the rear of the 2100 bioanalyzer.
- 2 Open the lid and pull the metal lever on the inside left of the lid to the vertical position as shown in Figure 2. When the lever is in the vertical position, the cartridge is released from the lid by about 10 mm.
- 3 Gently pull the cartridge out of the lid as shown in Figure 3, “[Removing the Electrode Cartridge](#)”.

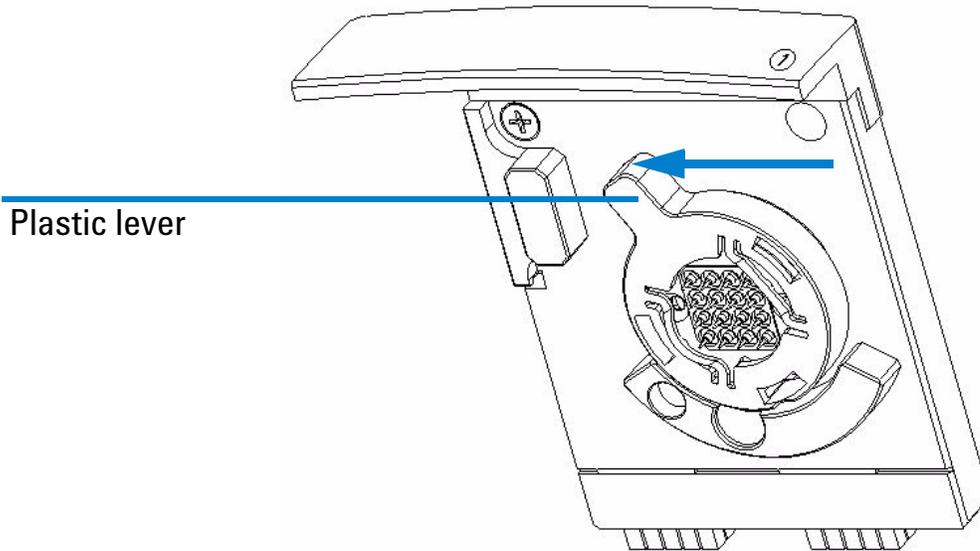
Figure 4 Opening the bayonet socket of the Pin Set

- 4 Open the bayonet socket of the pin set by turning the plastic lever to the left as described in Figure 4, “Opening the bayonet socket of the Pin Set”.

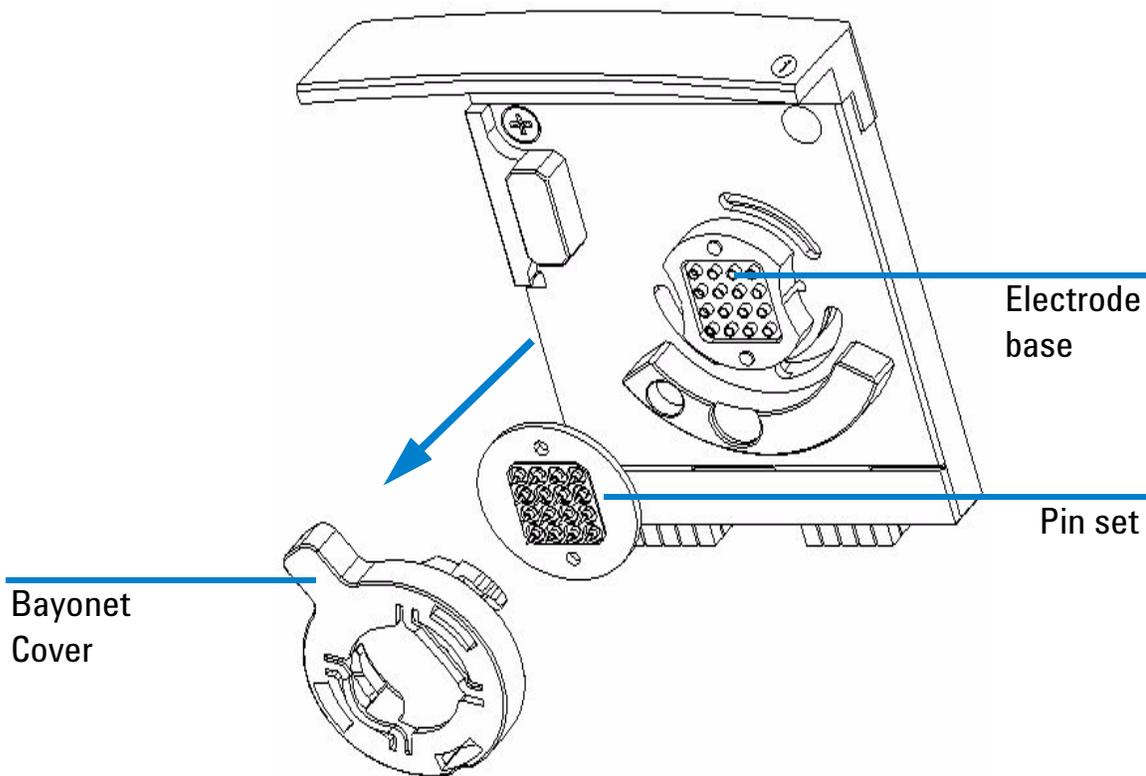
Figure 5 Releasing the Pin Set

- 5 Remove the cover of the bayonet socket by gently pulling the plastic lever. The pin set may stick to the electrode base. Remove it by carefully pulling it off. See Figure 5, “Releasing the Pin Set”.

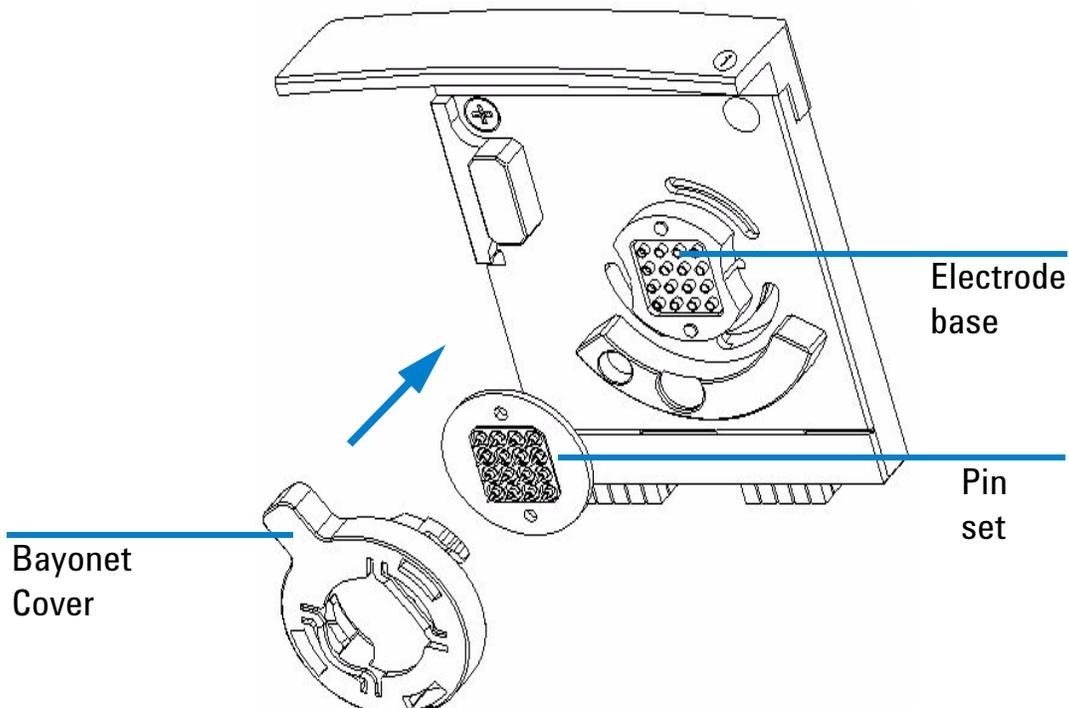
Figure 6 Inserting the Pin Set

10 Put the pin set on the cartridge base and the bayonet cover on the pin set. See Figure 6, “Inserting the Pin Set”.

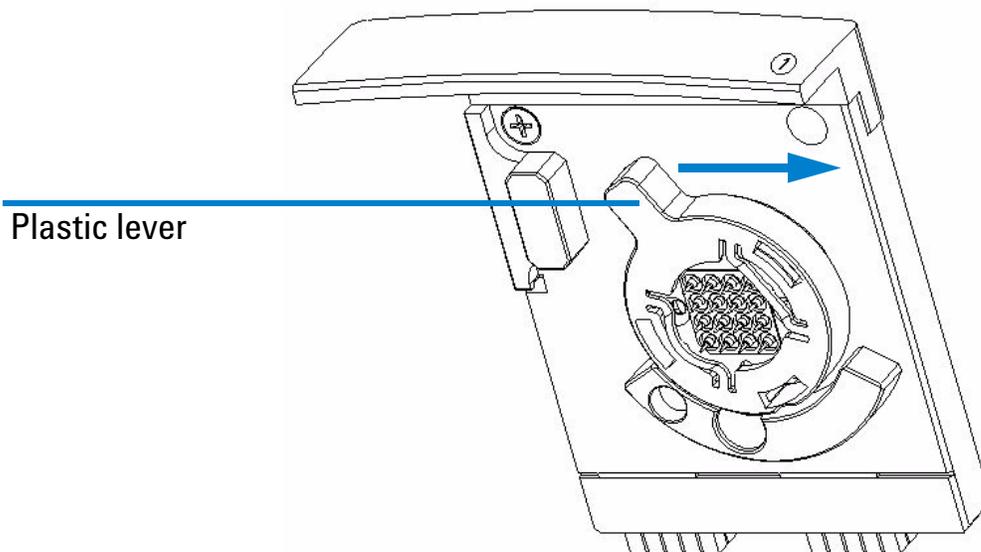
Figure 7 Closing the Socket of the Pin Set

11 Lock the pin set to the electrode base by pushing the plastic lever of the bayonet cover to the right as shown in Figure 7, “Closing the Socket of the Pin Set”.

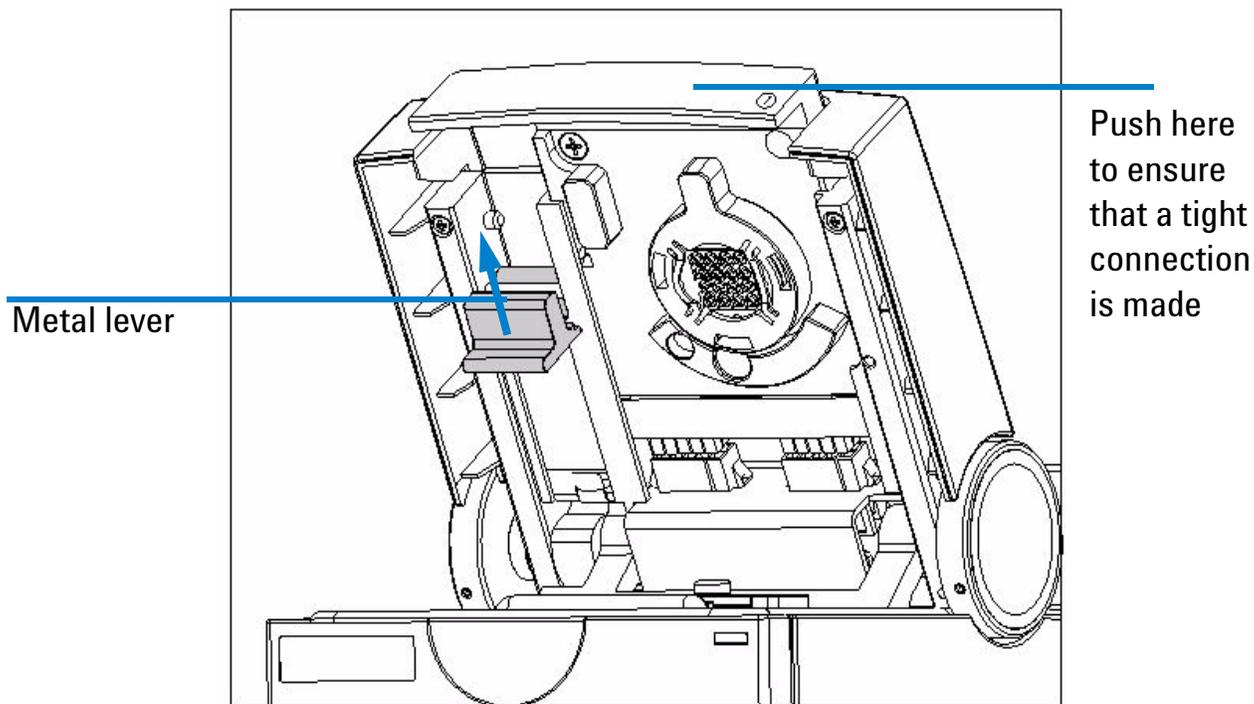
Figure 8 Inserting the Electrode Cartridge

- 12** Slide the electrode cartridge with the pin-set into the bioanalyzer lid as shown in Figure 8, “Inserting the Electrode Cartridge” and move the metal lever in the flat (closed) position.
- 13** Push the metal front of the electrode cartridge to ensure a tight connection to the 2100 bioanalyzer.

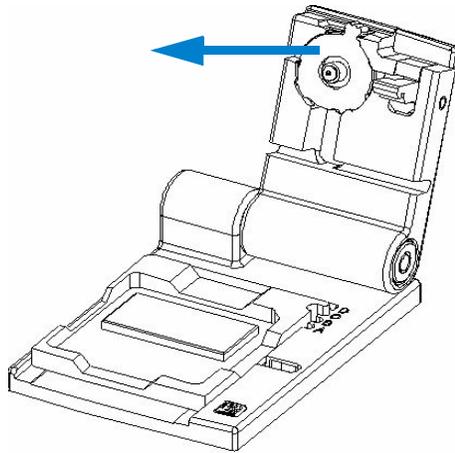
- 1 Remove the syringe by gently pulling it out of the adapter.
- 2 Open the Chip Priming Station.
- 3 Move the ring holding the adapter in place to the left as shown in Figure 9, “Releasing the Mounting Ring of the Syringe Adapter”. The ring will come off.

Figure 9 Releasing the Mounting Ring of the Syringe Adapter

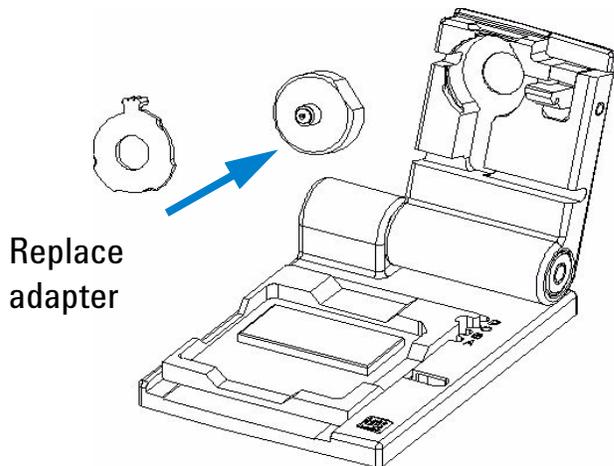
- 4 Press the syringe adapter out of its mount and dispose it according to good laboratory practices, as shown in Figure 10, “Replacing the Syringe Adapter”.
- 5 Insert the new syringe adapter.

Figure 10 Replacing the Syringe Adapter
