Agilent 2100 Bioanalyzer Maintenance and Troubleshooting Guide

Edition November 2003

Manual Part number: G2946-90001

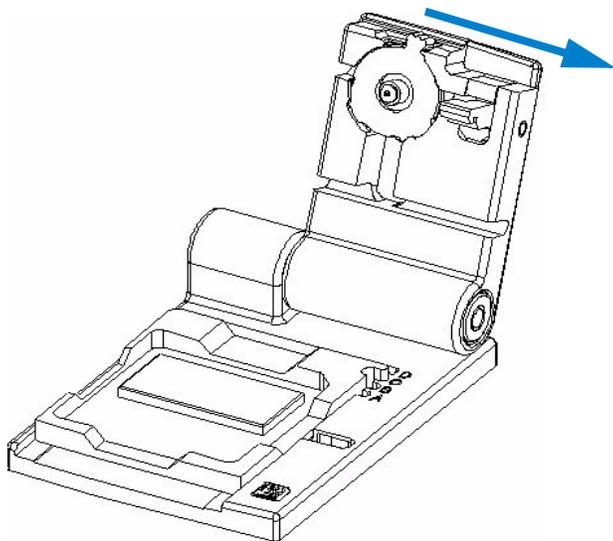
- 6 Insert the mounting ring and move it to the right in order to fix the syringe adapter as shown in Figure 11, “Fixing the Syringe Adapter”.

Figure 11 Fixing the Syringe Adapter

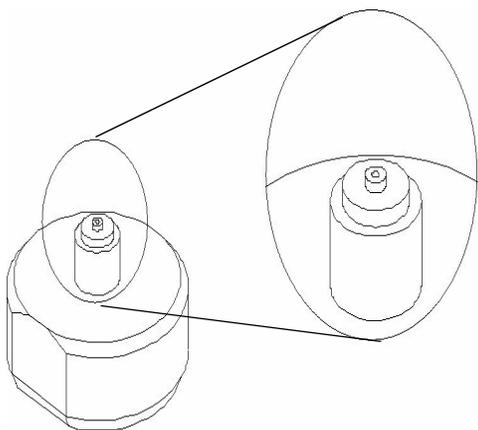
The silicone gasket, see Figure 12, “[Syringe Adapter with Gasket](#)”, ensures a tight connection between chip and syringe adapter.

Figure 12 Syringe Adapter with Gasket

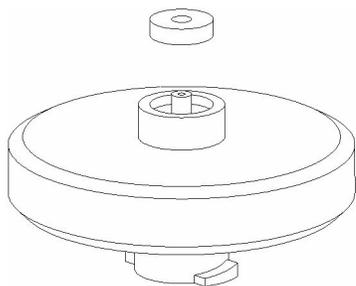
- 2 Pull out the old gasket with your fingers or with the help of a needle. See Figure 13, “[Syringe Adapter with disassembled Silicone Gasket](#)” for a disassembled adapter.

Figure 13 Syringe Adapter with disassembled Silicone Gasket

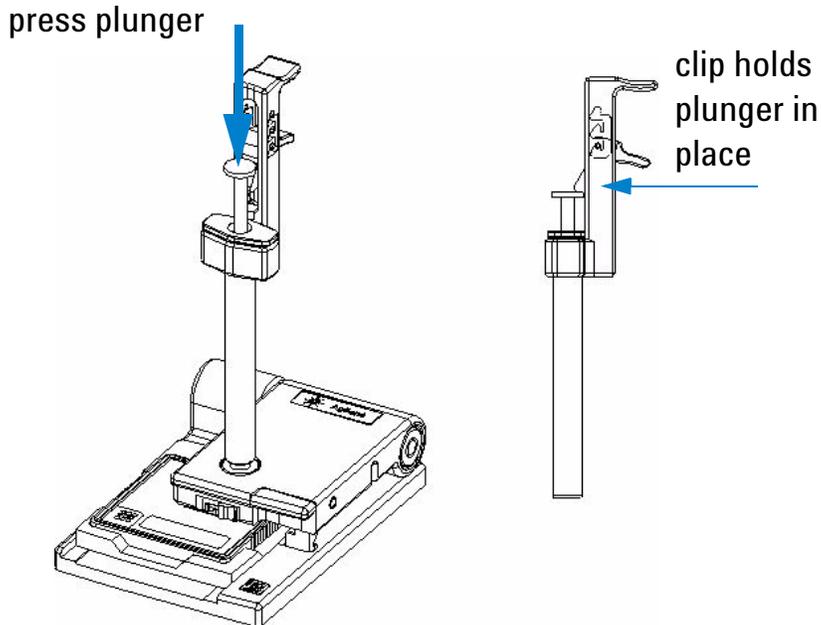
- 5 Press the plunger down until it is locked by the clip. This is shown in Figure 14, “Locking the Plunger of the Syringe with the Clip”.

Figure 14 Locking the Plunger of the Syringe with the Clip

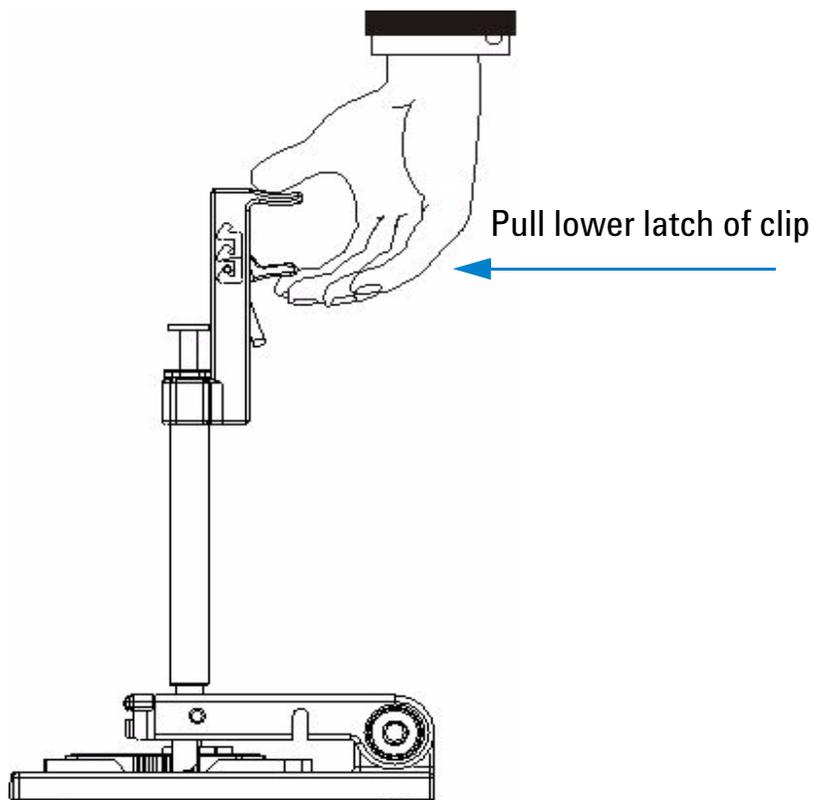
- 6 Wait for 5 seconds and press the side of the clip to release the plunger as shown in Figure 15, “Releasing the Plunger of the Syringe”.

Figure 15 Releasing the Plunger of the Syringe

- 7** Appropriate sealing is verified, if the plunger moves back up to the 0.3 ml mark within less than 1 second.

If the plunger doesn't move up to the 0.3 ml mark within a second, the syringe-chip connection is probably not tight enough. Re-tighten the syringe or replace the syringe adapter, syringe or gasket to fix the problem.

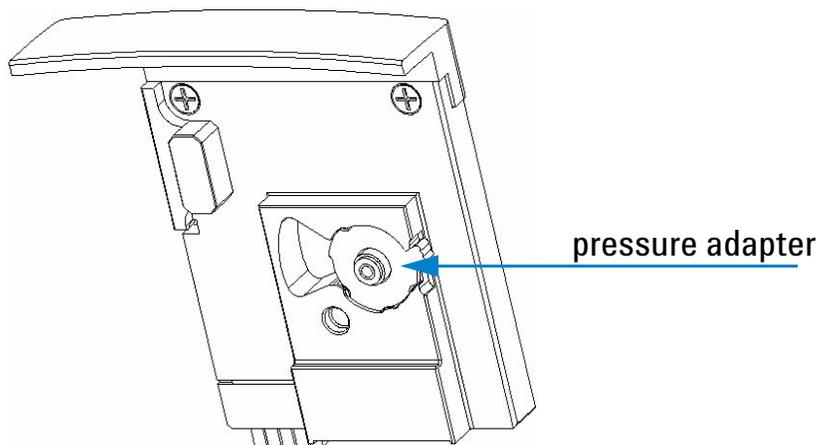
- 1 Open the instrument and remove the chip.
- 2 Should there be liquid at the adapter of the pressure cartridge, use a tissue to dry off the gasket. Make sure not to touch the lens.

Figure 16 Pressure cartridge with pressure adapter.

When the chip run is finished, immediately remove the chip out of the Agilent 2100 bioanalyzer. Then perform the following procedure to ensure that the pressure adapter, see Figure 16, “[Pressure cartridge with pressure adapter.](#)” on page 215, is clean and no residues are left over from the previous assay.

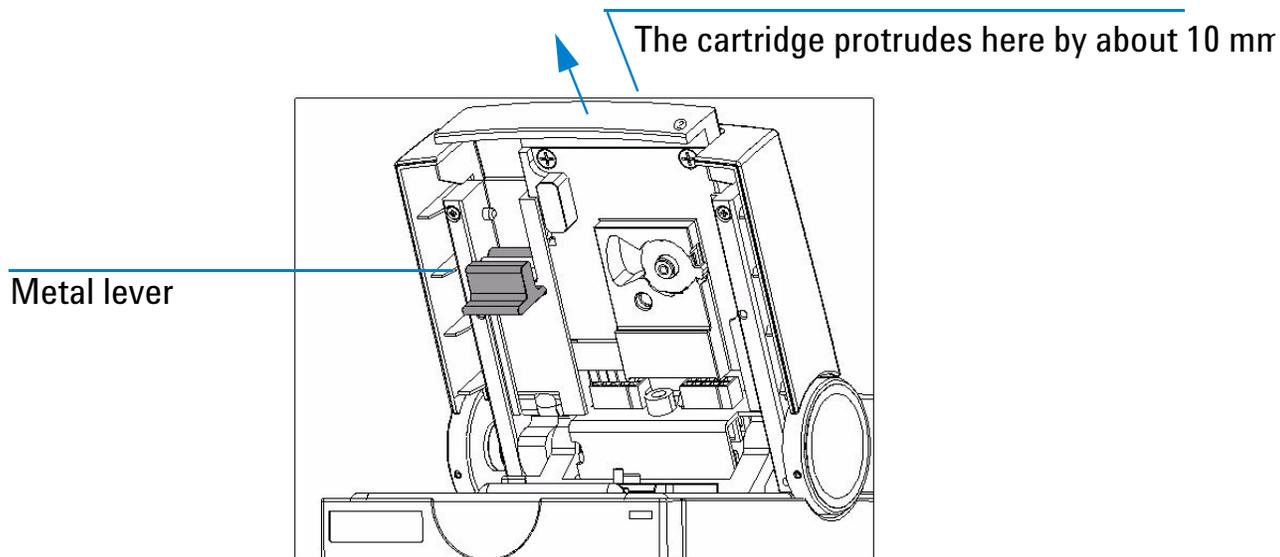
- 1 Switch off the instrument. The line switch is located at the rear of the 2100 bioanalyzer.
- 2 Open the lid and pull down the locking lever on the left inside the lid to the open position as shown in Figure 17, “[Removing the pressure cartridge](#)”. The cartridge is pushed out about 10 mm.

Figure 17 Removing the pressure cartridge

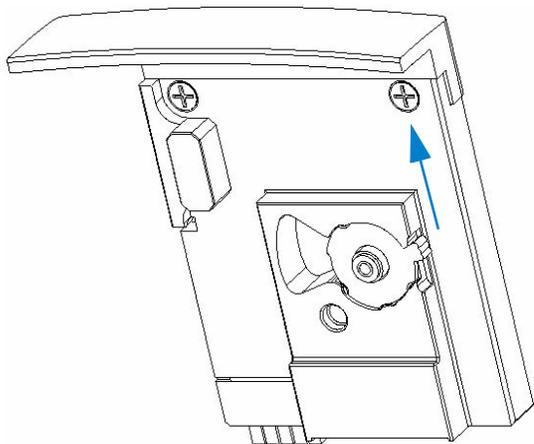
- 4 Move the ring holding the adapter in place to the left as shown in Figure 18, “Opening the ring of the pressure cartridge”. The ring will come off.

Figure 18 Opening the ring of the pressure cartridge

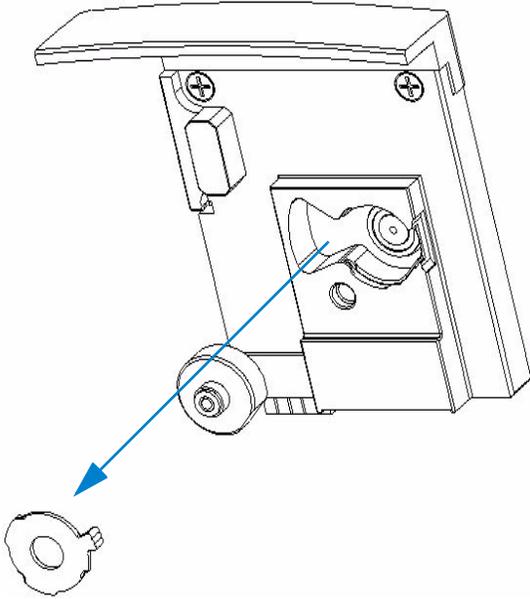
- 5 Pull the pressure adapter out of its mount, and replace it, as shown in Figure 19, “Releasing the pressure adapter”.

Figure 19 Releasing the pressure adapter

- 6 Re-insert the new pressure adapter and lock it by the mounting ring. Make sure that the pressure adapter is inserted correctly; it fits only one way.

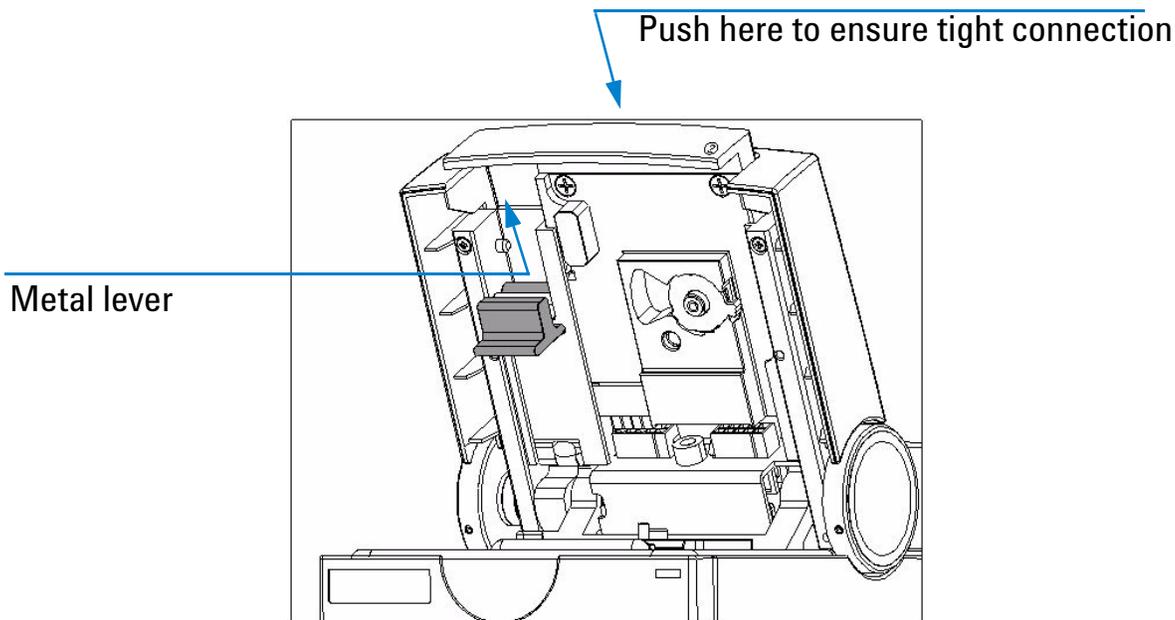
- 7 Slide the Pressure Cartridge in the lid as shown in Figure 20, “Inserting the pressure cartridge”.
- 8 Move the metal lever in the flat (closed) position.
- 9 Push the metal front of the pressure cartridge to ensure a tight connection to the 2100 bioanalyzer.

Figure 20 Inserting the pressure cartridge

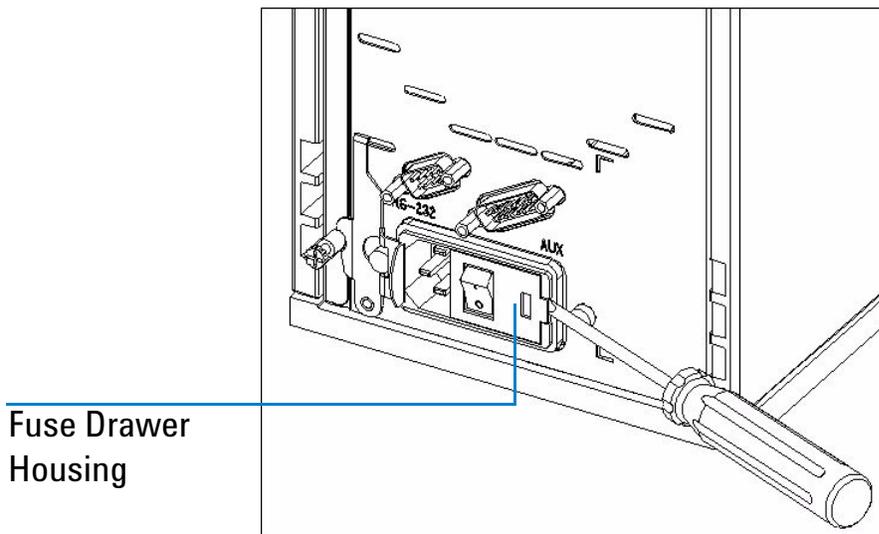
- 3 To access the fuse drawer, gently lift the outer plastic housing of the power inlet socket using a screwdriver, see Figure 21, “Lifting the Housing of the Power Inlet”.

Figure 21 Lifting the Housing of the Power Inlet

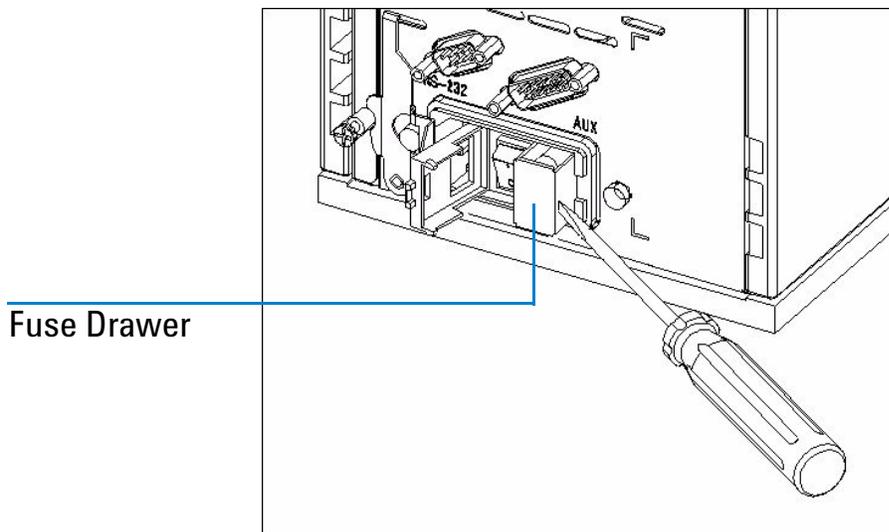
4 Pull out the fuse drawer as shown in Figure 22, “Pulling out the Fuse Drawer”.

Figure 22 Pulling out the Fuse Drawer

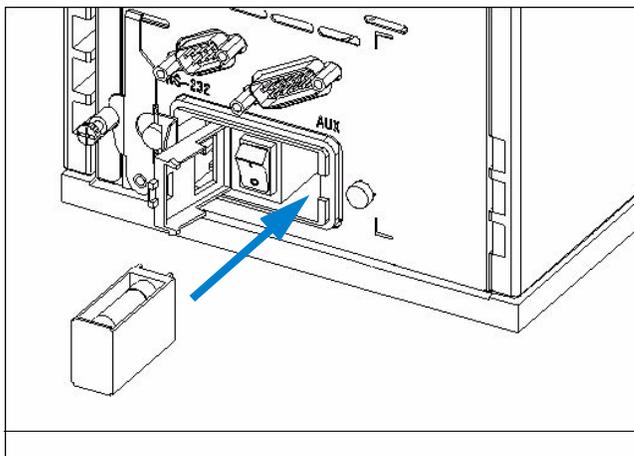
- 6 Slide in the fuse drawer and push till it fits tightly as shown in the Figure 23, “Slide in the Fuse Drawer”.

Figure 23 Slide in the Fuse Drawer

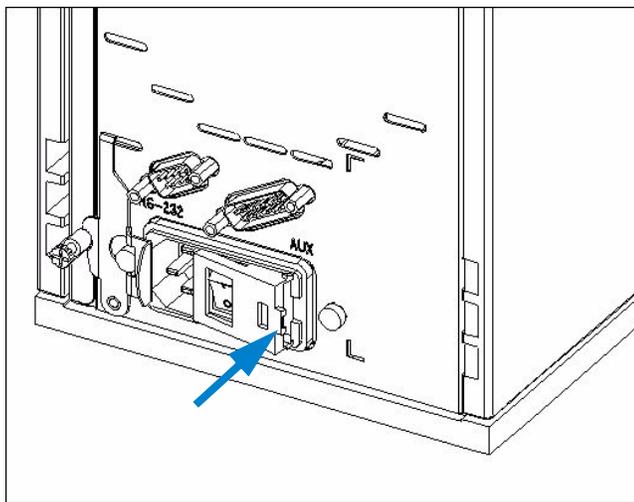
- 7 Finally, close the fuse drawer housing, reconnect the instrument to the power line and switch it on.

Figure 24 Close Fuse Drawer Housing
